IMCA Safety Flash 12/11

October 2011

I Offshore Tank Container Rigging Failure

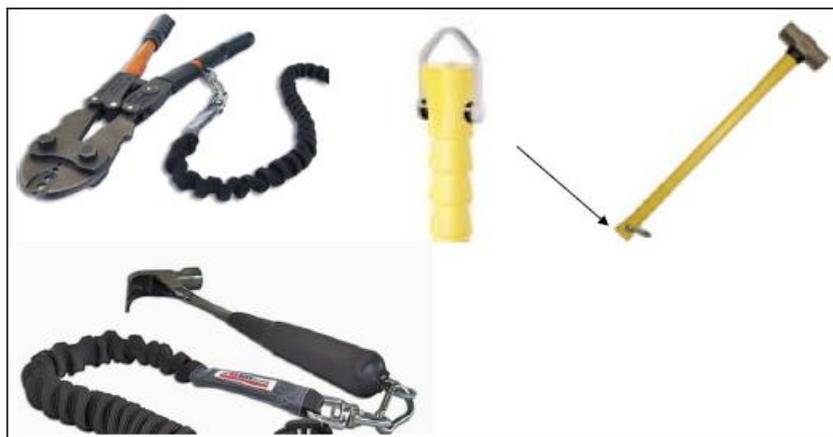
Some suggested tool lanyard arrangements

- ◆ The inspection for damage of all hand tools should always be carried out prior to use and before returning to storage location;
- ◆ Hammer heads should be checked for security prior to use, ensuring heads are securely fixed to handle;
- ◆ Defective tooling should be removed from service and quarantined;
- ◆ Appropriate tool retention methods should be used when working at height with tools; different methods may be appropriate for tools of different weight;
- ◆ The tool lanyard connection point should either be supplied with the hammer, recommended by the tool manufacturer or be a recommended and approved lanyard manufacturer's modification.

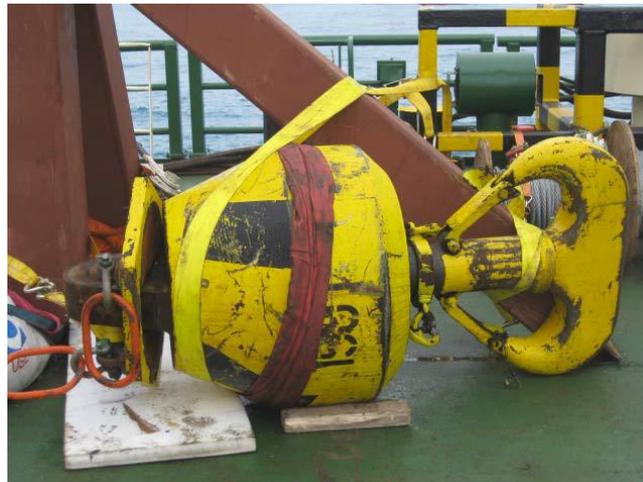
A member has reported an incident in which, owing to the sudden movement of the vessel, a crane winch wire hit the crane cab with the operator inside, causing damage to the cab structure. The operator was unharmed. The incident occurred after completing the wet storing of a spool using the single fall main block. The crane boom, complete with suspended spool lift rigging, was recovered to the main deck. Whilst the block was over the deck, the vessel pitched and rolled heavily thus causing the crane block to swing adversely. The crane operator attempted to recover the situation. As he attempted to recover the block, the wire immediately above the block hit the crane cab damaging the cab structure and breaking glass. The impact showered the crane operator with glass.

Crane block

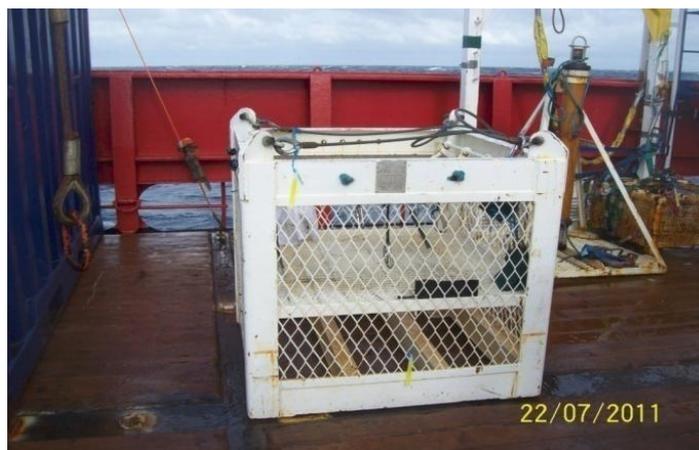
Dive control requested that diver 1 make his way to the top of the manifold to prepare for the basket being landed. When he arrived at the manifold he could not see the load and was told it was on its way down. While he was waiting for the load to arrive he started to inspect the landing zone to ensure it was clear to land the work basket. As he was doing so, the deployed work basket suddenly landed behind him on top of the manifold.

Diver 1 called an immediate 'all stop!' and at the same time the crane driver informed dive control that as per his line out meter he had reached the required short mark. During this operation the ROV had not been requested to spot the load at any point during the deployment.

Typical 1m x 1m work basket for deployment subsea

- ◆ There was no written and agreed procedure for this operation with lifts being completed using usual practice;
- ◆ There had been no risk assessment for deploying subsea loads from the crane;
- ◆ There was no lift plan in place for the work basket and hence no discussion of the work basket during toolbox talks, which might have highlighted potential hazards and considerations for personnel involved;
