IMCA Safety Flash 12/18

June 2018

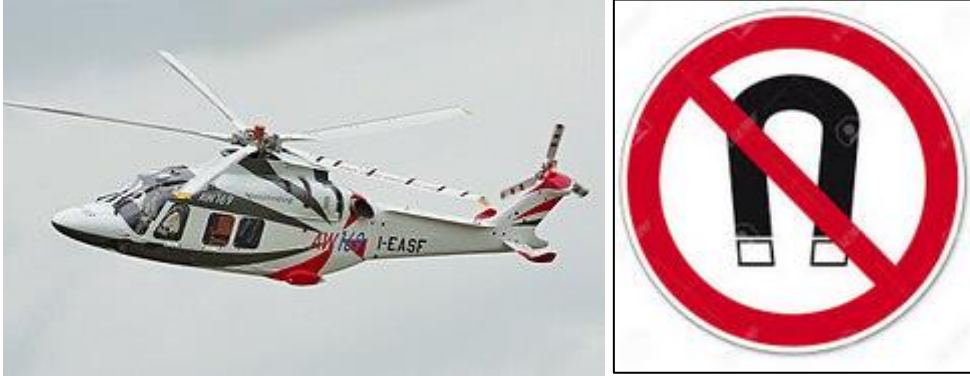
On a normal (passenger) crew change flight in an AW169 helicopter, crew noticed a “1-2 AHRS FAIL” caution displayed in the crew alert system shortly after departure from the offshore installation. With this caution message, electronic helicopter heading information was completely lost.

The cause of the instrument failure was found to be due to the presence of magnetic elements (speakers) in the luggage hold.

- ◆ The helicopter equipment involved in the occurrence was checked for damages and for correct function. No damage nor discrepancies were found; the helicopter was released for service;
- ◆ Check-in personnel now inform passengers that stereo speakers are not permitted on board helicopters;
- ◆ Check-in personnel make random checks of passengers' luggage (as approved by customer/passenger) for items not to be transported onboard helicopters;

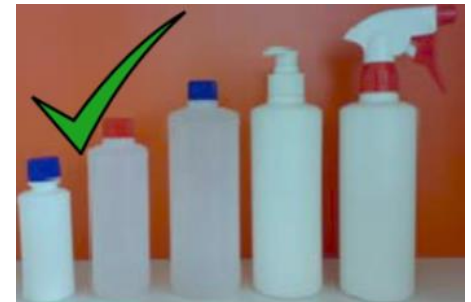
- ◆ Initial investigation revealed that the third-party contractors working onboard had temporarily stored thinner in the mineral water bottle;
- ◆ The third-party contractors were inadequately briefed and behaved in an unsafe way – unsafe practice was used by the third-party contractors.

Crew and third-party contractors were reminded to only store chemicals in proper, appropriately marked containers. Crew were recommended to refrain from drinking water from shared bottles in common places, and to carry their own bottle.
