IMCA Safety Flash 12/20

March 2020

1 Chain Hoist Failure Resulting in a Serious Near Miss

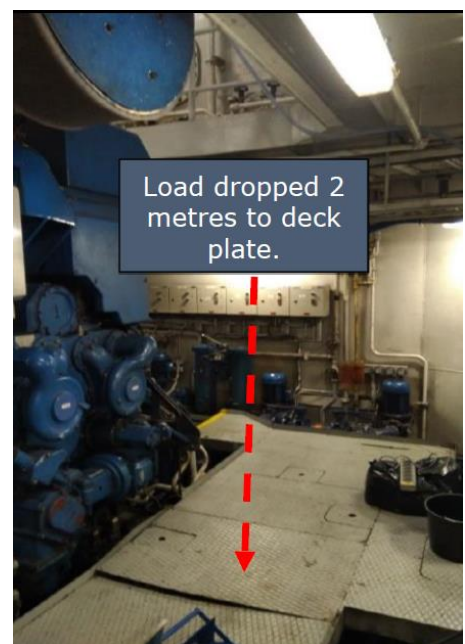
Hoist clutch plate (overload device) showing extensive corrosion on friction bearing surfaces.

The unit was infrequently used and was not subjected to internal inspection; this allowed the internal braking mechanisms to suffer corrosion, and this prevented the braking function operating properly when under load.

The above resulted in the clutch failing to hold the load, lowering the charge air cooler to the engine room deck plating in an uncontrolled and rapid manner.

- ◆ Full inventory made of all powered hoists (pneumatic and electric) to include both chain hoists and wire hoists and not restricted to permanently installed units;

- ◆ Additional relevant maintenance scope added to planned maintenance scopes for all these devices;
- ◆ Powered hoists fitted with overload devices should be set at working load limit +10% and checked annually as part of the planned maintenance regime.

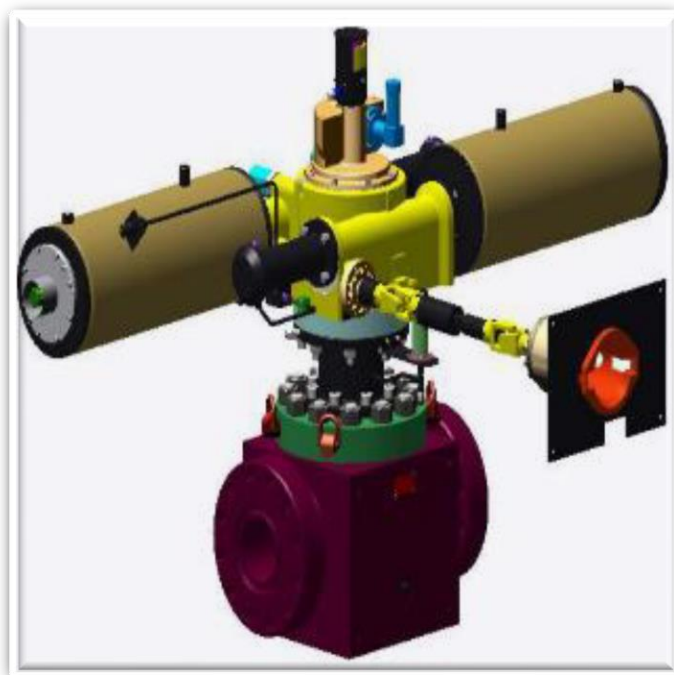
A diver was asked to operate an ROV override switch with a hand-held torque wrench. The operation was observed by a third-party technician who intervened and stopped the job. The use of a hand-held torque wrench to operate an ROV override on the valve was inappropriate due to the possibility of a sudden uncontrolled unwinding of the spring mechanism, which could have caused the torque wrench to rotate and hit the diver.

- ◆ The warnings on the GA (general assembly) drawing stating that hand-held tools should not be used were ambiguous and were missed;
- ◆ The valves procedure issued by the client did not include a warning or highlight the dangers of using hand-held tools to operate the ROV override;
- ◆ Engineers were not issued with the appropriate installation operations manual, which included warnings not to use hand-held tools;
- ◆ The assumption was made that a hand-held torque wrench could be used. Our member notes that similar incidents have occurred within the organisation.

Any operation of an ROV override on a double actuated spring $\frac{1}{4}$ turn ball valve (fail safe) should not be operated with a manual hand-held torque tool, unless there is clear confirmation from the client or the valve manufacturer that it is safe to do so.
