IMCA Safety Flash 16/13

October 2013

2 Fatality – Man Overboard

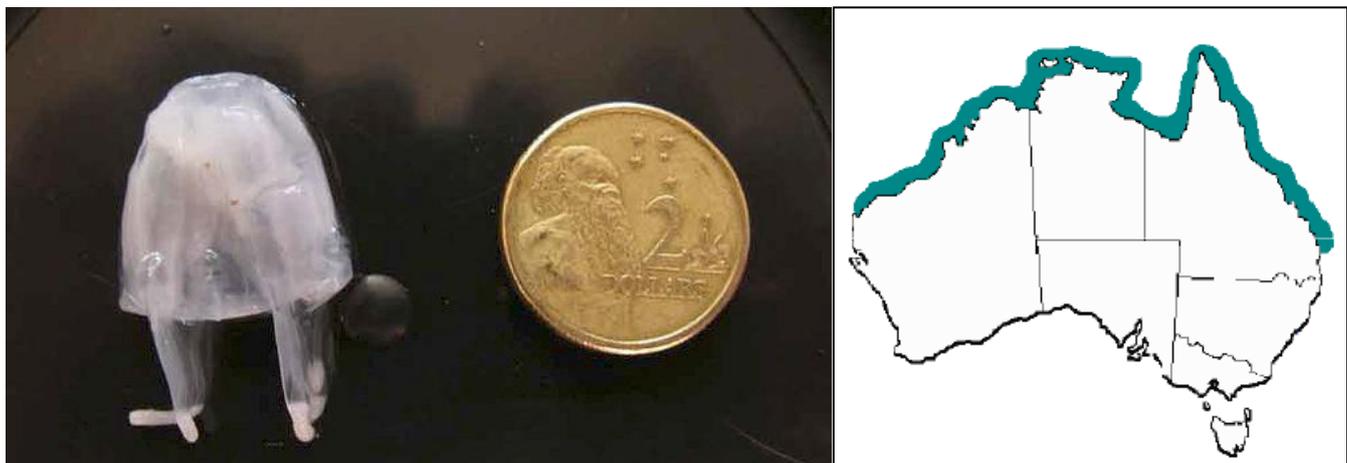
There are at least 10 species of Irukandji known, ranging from as small as 1cm to over 10cm in diameter; all are transparent and virtually invisible in water which makes them difficult for swimmers and/or divers to notice. Irukandji are most likely to be found in Australian tropical waters (see map). The normal Irukandji season begins from November through to May.

(L) Irukandji jellyfish (R) Areas in which Irukandji jellyfish are most likely to be found

Often the greatest threat is not to the diver but to tenders on deck handling divers' umbilicals and associated lines that have been submerged. Great care should be taken by topside personnel, paying particular attention to covering exposed skin by wearing gloves and long sleeve coveralls at all times.

If hot water suits are being used in tropical waters (for example, by saturation divers) there should be adequate filtration of water intakes in place to prevent jellyfish, or parts of jellyfish, from being drawn into the hot water suit intakes and then being pumped down to the divers' hot water suits. Sufficient PPE to prevent jellyfish stings should be worn by anyone required to clean such water intake filters.
