IMCA Safety Flash 16/16

June 2016

1 Dropped Object: Signage Dropped From Crane Boom

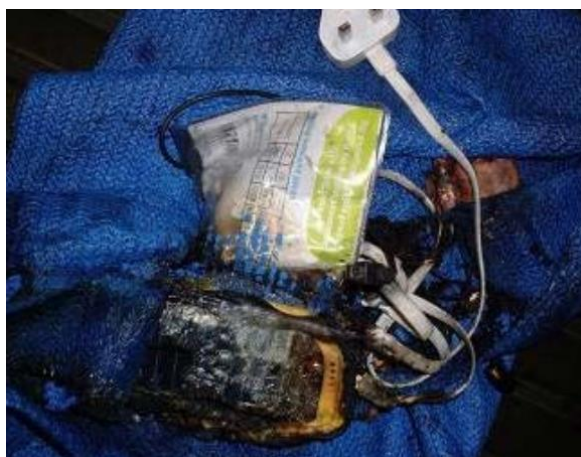
The Marine Safety Forum has reported a small fire in a crew member's cabin on a vessel. It was thought to have been caused by the overheating of a battery. The crew member who was not in his cabin at the time, had left a power bank (battery pack for charging small appliances) charging and unattended. This unit appeared to be a cheap unit purchased online.

Members should take great care with mains battery chargers, lithium battery 'power banks' and USB cables that are not "OEM" (Original Equipment Manufacturer). It is particularly important to ensure that USB cables are appropriate to safely handle the higher levels of current delivered by some modern chargers.

Portable electrical equipment brought on board vessels should be checked and rated against the ships power supply by qualified personnel. Electrical items should not be left charging, or on standby, in unoccupied spaces (such as cabins.)
