IMCA Safety Flash 18/15

November 2015

2 Maintenance of Automatic External Defibrillators (AED)

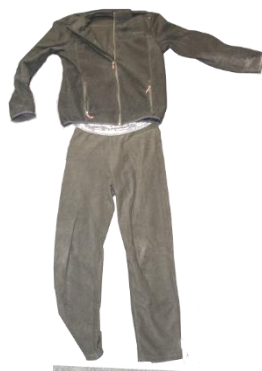
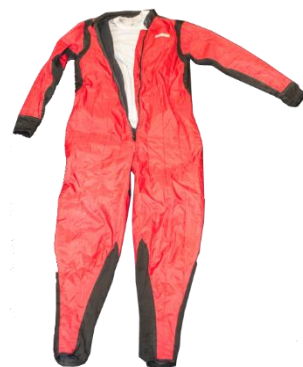
After comparison of the combination of dry-suit undergarments divers B and C were wearing, including consulting manufacturer's recommendations, it was concluded **that they were insufficiently dressed for the temperature conditions.**

- ◆ Diver A's long sleeved gloves were too tight;
- ◆ Divers B and C were using undergarments insufficient for the conditions of the dive.

Diver A	Diver B	Diver C
Dry-Suit	Northern Diver Origin 6,5mm XO grade neoprene	Bare CD4 3,5mm compressed neoprene	Bare D6 Pro 6mm compressed neoprene
Undergarment	Inner suit (Subgear Subtech 100)	T-shirt, Fleece jacket, Training pants	Thermal shirt (long sleeves, synthetic) and inner suit (summer type)

- ◆ Divers should wear correct and sufficient clothing for the dives they are going to make – in terms of duration, type of work, and sea water temperature. This should include sizing (garments should be properly fitted) and insulation properties (under-suits that are made of suitable materials in view of compression, moisture absorption and thermal properties):
- ◆ Supervisors should consider restriction or adjustment of the dive profile (e.g. reduce bottom time and/or tasks) if a diver does not have the possibility to wear the appropriate clothing, so that increased risk of DCI is avoided.

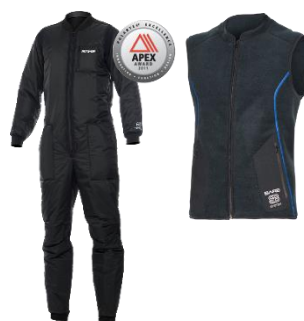
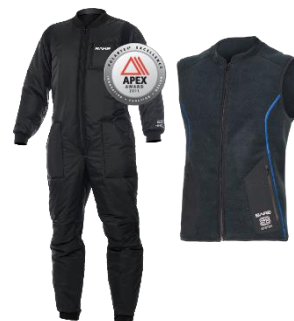
Manufacturer's Recommendations

Metalux Temperature Undersuit (100gsm/200gsm)

SB Mid Layer Vest + CT200 (inner suit - 210gsm)
