## IMCA Safety Flash 25/16

October 2016

### 1 Fire-Fighting Water Jet Hits Antenna – Failure of Limits, Stops and Safeties

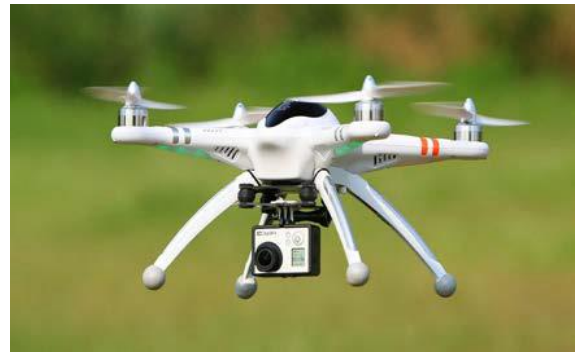
A member has reported an incident in which the Suez Canal Authority has recently detained a vessel following the launch of a drone to photograph the vessel proceeding through the Suez Canal. During the Suez Canal Authorities (SCA's) subsequent inspection, they confiscated the drone and its memory card and the vessel was detained in anticipation of further investigations by the Egyptian authorities.

Although the intention when launching the drone was simply to document the vessel proceeding through the Suez Canal, the use of the drone may have been considered a threat to national security by the Egyptian authorities.

Our members' recommendation was that drones and unmanned aircrafts should not be used in port or sailing within a country's territorial waters except for official reasons and with agreed permission of the authorities and company.
