IMCA Safety Flash 34/16

December 2016

1 Offshore Crane Safety Systems

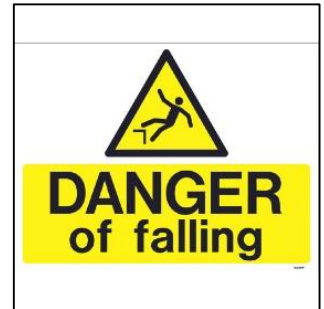
Step Change in Safety has published the following safety alert regarding a near miss incident in which there was a potentially very serious failure of a safety gate at height. During a routine inspection, whilst stepping from a ladder onto a gantry, the crewman performing the inspection discovered that the safety gate bar was adrift from its hinge bracket. The crewman narrowly avoided a fall. He replaced the gate bar and immediately reported the event. There were no injuries.

Investigation revealed that a retaining plate and bolt were missing due to the bolt working its way loose. The bar was repaired immediately. Ongoing checks of all such safety gates took place to ensure they are functioning correctly and safely. In the long term, a review was arranged of the maintenance strategy of the safety gates.
