IMCA Safety Flash 24/20

August 2020

1 Hull damage caused oil leakage from settling tank

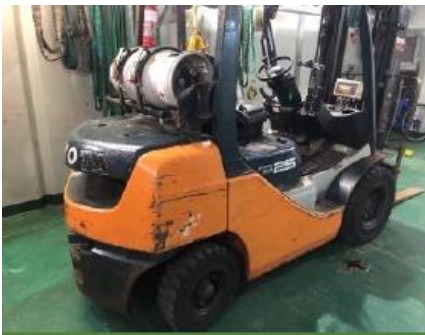
In a vessel alongside, a new fuel gas cylinder was connected to a gas-powered forklift truck. When the delivery valve was opened gas leaked from the connection between the cylinder and the hose. The cylinder was removed and the internal O-ring seal was found to be damaged.

Small LPG-powered fork-lift truck

- ◆ Closely examine exchanged or pre-used equipment for proper condition, especially where potentially hazardous materials or stored energy is concerned. **It always pays to check.**
- ◆ O-ring seals are small but vitally important components which should be treated with the greatest of respect.

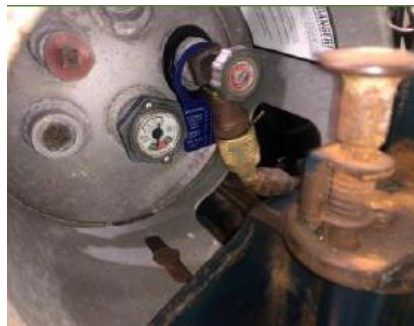
Tank valve and fuel line

A replacement cylinder was brought to the forklift but before fitting it the crew member checked the condition of the O-ring and found that it too was damaged. Fortunately, a number of full spares are carried on board and one was found that was in good condition.
