# IMCA Safety Flash 10/15

July 2015

## I Near Miss: Dropped Object Fell from Crane Boom

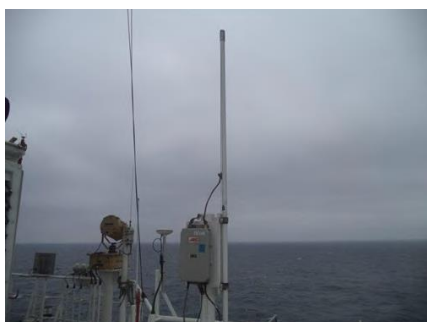
A member has reported a near miss incident in which part of a single side band (SSB) antenna fell off the mast to deck during bad weather. The antenna had three parts which were threaded and screwed together. The first part of the antenna was not fully screwed into the second part. In high winds, the antenna was waving back and forth in the wind which caused it to loosen and become detached. There were no injuries.

SSB antenna above bridge

- ◆ Damaged antenna was removed from above bridge and replaced with new one;
- ◆ Ensured correct practices were used for securing all navigation/communication equipment at height and/or on masts;
- ◆ Thorough check of all existing equipment above bridge or at height and/or on masts, most especially after installation or maintenance by a third party;
- ◆ Crew “time out for safety” carried out emphasizing hazards and risks of working at height and/or on masts, particularly the area above the vessel bridge (sometimes called the *monkey island*).
