IMCA Safety Flashes summarise key safety matters and incidents, allowing lessons to be more easily learnt for the benefit of all. The effectiveness of the IMCA Safety Flash system depends on Members sharing information and so avoiding repeat incidents. Please consider adding safetyreports@imca-int.com to your internal distribution list for safety alerts or manually submitting information on incidents you consider may be relevant. All information is anonymised or sanitised, as appropriate.

1 NTSB: Flooding, sinking and loss of tugboat *Mangilao*

2 NTSB: Overturning of the Liftboat *Kristin Faye*

3 MSF: Cargo snagging

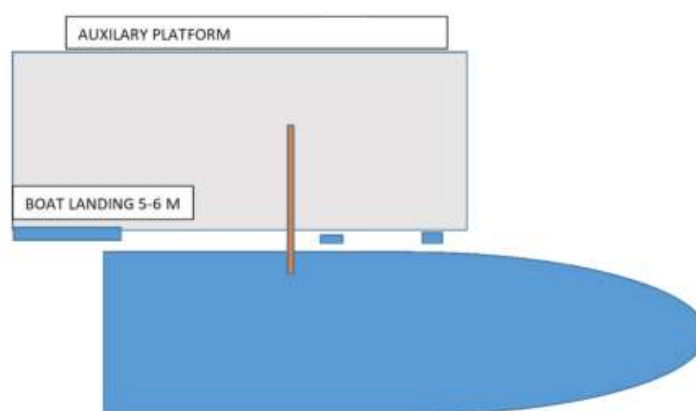
In addition, it was noted that the vessel did not have the appropriate lifting gear to handle such a heavy lift. The Master determined that the operation was unsafe and called it off, having informed all relevant stakeholders accordingly.

The Master did his utmost to meet client expectations. However, he exercised **stop work authority** after having determined the unfeasibility of the operation based on his situational awareness.
