1 Dutch Safety Board: fatality when mooring line snapped

2 Near miss: uncontrolled movement of mooring chain

3 Lifeboat Wire Rope Failure

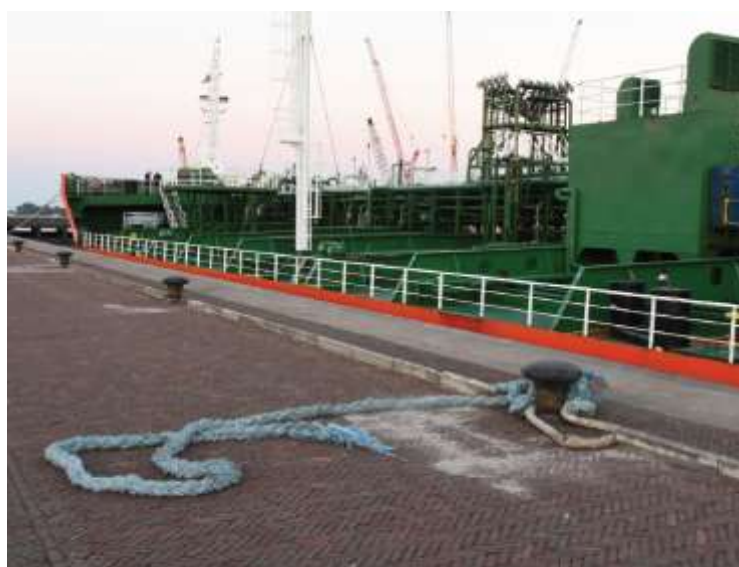
The Dutch Safety Board has issued the following report on a mooring line fatality onboard chemical tanker *RN Privodino* on 28 June 2018, while entering the Noordersluis lock at IJmuiden, en route to Amsterdam. Shortly after the port forward spring had been paid out, it unexpectedly came under severe tension. The mooring team on the foredeck was no longer able to respond adequately in good time, as a result of which the mooring line parted. The section of mooring line that was connected to the on-board winch recoiled, and struck a crew member, killing him instantly.

- The forward spring broke because, with the spring already wrapped around the bollard on shore, the vessel was still moving forward when the forward spring on the mooring line winch was transferred from the storage drum to the tension drum, at which time the forward spring could no longer be paid out quickly enough. This transfer was carried out without the relevant instructions being issued;
- The mooring team leader on the foredeck was unable to monitor the actions of the operation of the mooring line winch and was also not informed of those actions;
- The mooring team leader had no view whatsoever of the crewman. At that moment, the crewman was in a dangerous position on the foredeck, in the snap-back zone of the forward spring.

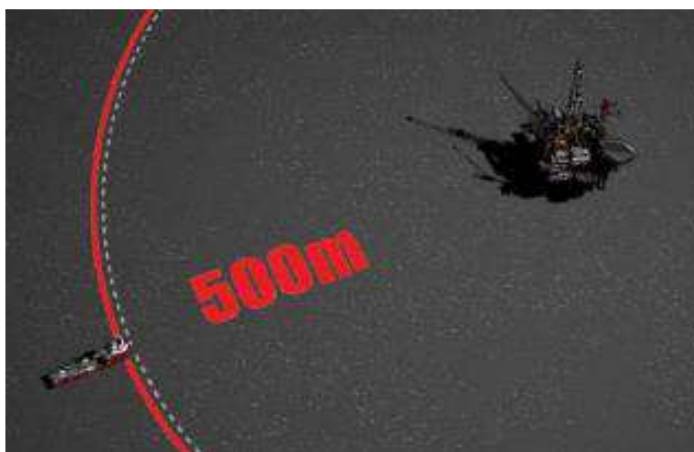
- There was only one watchkeeper – the Master - on the bridge at the time. Company procedures for having two watchkeepers on the bridge at all times, were not followed;
- The client’s voyage procedures were not followed;
- The Master was preoccupied with change-over procedure which took attention away from the vessel’s movement;
- The Master assumed that the vessel was going more slowly than it actually was, and had no expectation that the vessel would drift so close to the wellhead.

- Ensure that watchkeeping procedures for bridge operations are strictly followed;
- Ensure that client voyage procedures are strictly followed;
- Ensure that there are sufficient trained, competent and rested people available at all times for watchkeeping;
- Follow COLREGs at all times;
- If a watch officer needs to leave post, ensure a suitable replacement is found before doing so.
