IMCA Safety Flashes summarise key safety matters and incidents, allowing lessons to be more easily learnt for the benefit of all. The effectiveness of the IMCA Safety Flash system depends on Members sharing information and so avoiding repeat incidents. Please consider adding [safetyreports@imca-int.com](mailto:safetyreports@imca-int.com) to your internal distribution list for safety alerts or manually submitting information on incidents you consider may be relevant. All information is anonymised or sanitised, as appropriate.

## 1 Hand injury when caught in machinery

## 2 Injury to Fingers During Grinding Activity

### 3 LTI: Stored energy – rigger injured leg working on quayside

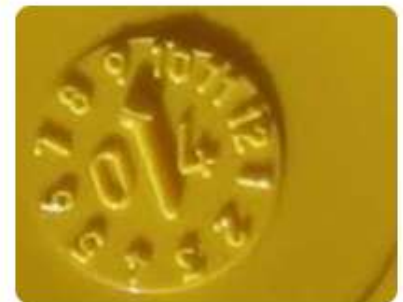
While cleaning a storage cabinet onboard a vessel, a safety helmet retained for use by visitors was found to be several years past its storage life expiry date.

This prompted the inspection of all in-use and stored/spare safety helmets onboard the vessel. The inspection identified **five helmets** which were past their recommended in-use life and **three helmets** past their storage life. Several safety helmet suspension systems were also found to be defective - faulty ratchet adjusters and torn webbing. An inspection on onboard another vessel working on the same project also found several out of date and defective safety helmets.

- ◆ Members are encouraged to check the procurement, storage and use of safety helmets;
- ◆ The storage-life and in-use life of a safety helmet is determined by the manufacture and whilst only a recommendation, should be followed;
- ◆ Spare safety helmets should be stored in accordance with the manufacturer's instructions. Exceeding the storage life will reduce its in-use life accordingly. Stock levels should be kept to a minimum and storage conditions monitored;
- ◆ When not being worn, in-use safety helmets should be stored safely and protected from damage.
