## 1 MAIB: Fatal accident during cargo operations on *Karina C*

## 2 Disabled audible alarm on fire alarm panel

## 5 Lead-acid battery explosion

## 6 Sludge Accumulation in Fresh Water Tank

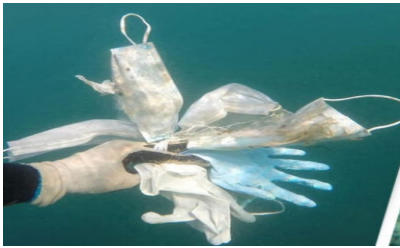
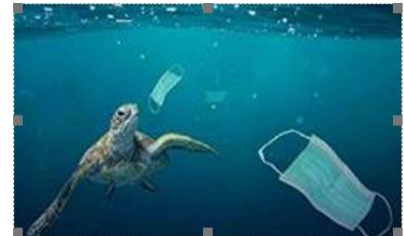
One of the PPE requirements to combat the spread of COVID-19 is the use of masks, because it is an efficient means of protecting ourselves and others. This has significantly increased demand and production of single-use surgical masks all over the world. However, it is also important that safe disposal of COVID-19 masks is taken into consideration.

- Face masks can take centuries to break down, thus having a profound negative impact for marine wildlife and ecosystems;
- The ear loops of a mask pose an entanglement risk for marine wildlife.

- Dispose of masks responsibly:
  - Be aware of the nature of the hazards and the risks involved in disposing of single-use masks;
  - Cut off the straps of the single-use masks before disposal;
  - Consider using re-usable face masks where possible.
