1 Dropped object during crane operations

2 Dropped Object – Steel deck plate falls from pipelay tower

3 Incorrect measurement and markings on divers umbilical

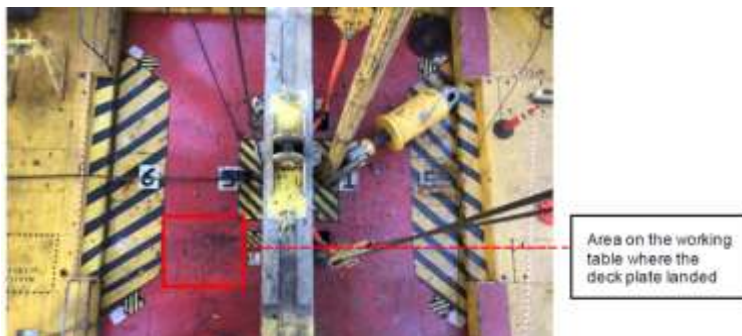
A large steel deck plate fell 9m from a pipelay tower to deck. The incident occurred on a vessel in dry dock, during which testing and inspection of the pipelay tower was taking place. A rope access technician stood on one of the steel deck plates located around the mid centralisers. The bolts securing the deck plate failed resulting in the deck plate upending and then falling to the deck below. The area below had been barriered off before work started. No-one was hurt. On inspection it was noticed that the deck plate fixings were heavily corroded, with three of the four securing bolts providing no support.

- This deck plate and others found were not part of the original pipelay tower structure, nor on any vessel drawings;
- No change management or design engineering was carried out;
- Incorrect size and material grade of bolts were used;
- The deck plate was only supported on the rear section, and no support bracket had been installed underneath the plate where the technician stood;

- Ensure all gratings, steel deck plates and their fixings installed at height are inspected as part of a routine inspection program;
- Ensure equipment modifications are controlled through the change management process.

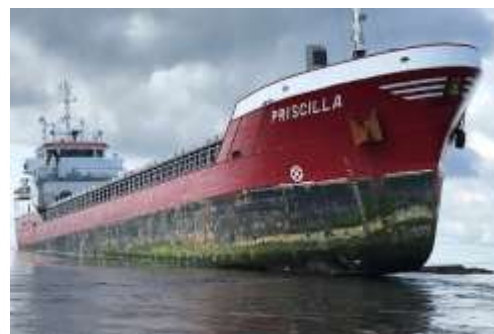
As part of its BSafe campaign, Britannia P&I Club describes a case where a vessel ran aground at night. The primary factor contributing to the grounding of the ship was the officer of the watch's failure to effectively monitor the ship's progress for about two hours.

The incident involved the general cargo vessel *Priscilla* and it occurred in July 2018. The UK Marine Accident Investigation Branch report on it can be found [here](#).
