1 Fatality: person crushed when secured material fell on him

2 Crane wire parted during offshore operations

3 Tumble dryer fire: lint ignition

4 Electric shock due to water in electrical equipment

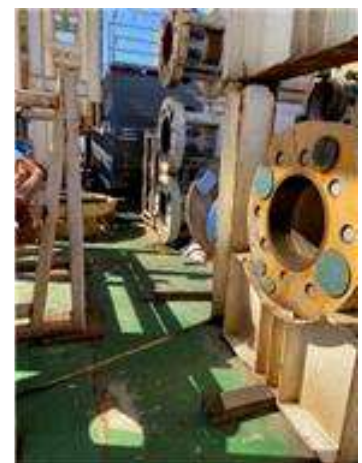
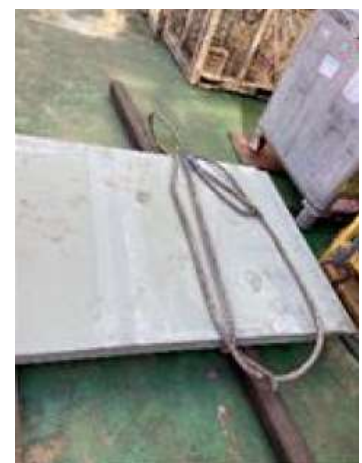
Stored metal plates fell on a crewman causing fatal injuries. This incident has been shared with one of our members by a client company, and is public domain news. The incident does not involve an IMCA member.

Third-party sub-contractors on a vessel were inspecting a sling that was wrapped around five metal plates. The plates were situated on two pieces of wood, positioned lengthwise on their edge and against a stanchion on the deck. The plates were secured to the stanchion by a ratchet strap. One crewman was trying to access a sling that was wrapped around the plates, so he instructed his co-worker to loosen the ratchet strap. When he gave the instruction, he was standing next to the plates. The co-worker followed the instruction and loosened the ratchet strap, which resulted in the plates falling toward the first person and pinning him against another storage rack on the riser deck. Several people ran to the scene immediately upon hearing calls for help, but the plates were too heavy for them to lift.

- Evaluate stored equipment and materials to minimize hazards related to stored energy and handling;
- Discuss the importance of hazard identification in the task planning process and using Time Out for Safety to manage changes in the work environment.

IMCA notes: this was an absolutely preventable and foreseeable incident. Please take time out to inspect any similar storage arrangements at your sites and ensure adequate controls are in place to prevent the same event happening.
