1 Near miss: vessel approach to wind turbine tower

2 Dropped Object – Crane auxiliary block dropped from crane boom

3 Shipyard worker receives electrical shock

4 SIMOPS - Smoke from hot work task enters confined space

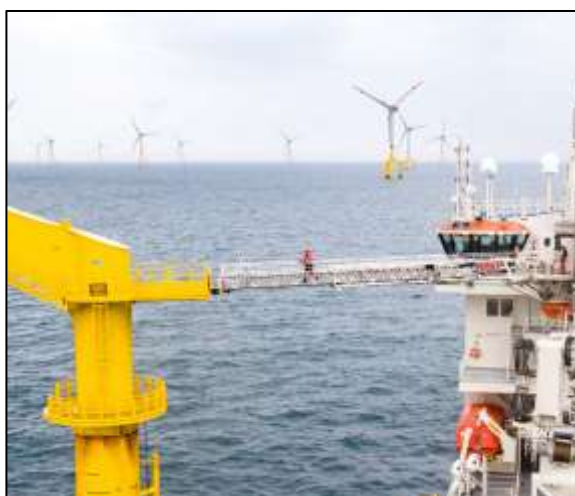
A member reports two near miss incidents within two weeks of one another, in which during the approach of a vessel to a wind turbine tower, the nacelle started moving, with the risk of the vessel being hit or gangway being knocked off by the wind turbine blades. No harm was done in either incident.

The turbine blades at this particular windfarm reach to within 23m of sea level at their lowest point. Thus, when the blades or the nacelle are turning, a ship within the turbine's safety zone could be struck. Therefore, safe docking and transfer of personnel requires a total STOP of the turbine. In STOP mode, the electric system is switched off, preventing any movement of the nacelle and/or the blades.

Investigations by the crew directly after the first incident event disclosed that the responsible person, working the software onboard the vessel, had not put the turbine in full STOP mode, but inadvertently put it in autonomous mode. It was suggested that the responsible person "*seemed a bit pressed that morning*", causing him to forget to click the (second) tickbox in the software to not only put the turbine in autonomous mode but also in STOP-mode.

In addition, the turbine's internal cables were at maximum twisted status, which occurs after a turbine has wound the maximum of 5 turns around the tower. A turbine in autonomous mode will automatically start yawing to unwind the cables. This was the initial cause of the near miss.
