1 BSEE: Crewman fell to his death through faulty grating

The United States' Bureau of Safety and Environmental Enforcement (BSEE) has published BSEE Panel Report 2021-001 into a fatal fall from a platform in the Gulf of Mexico in 2019.

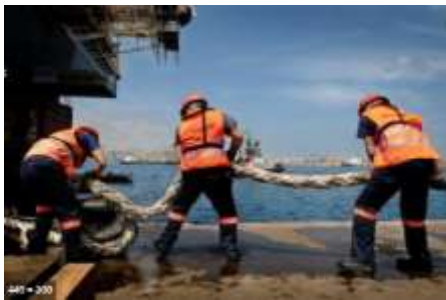
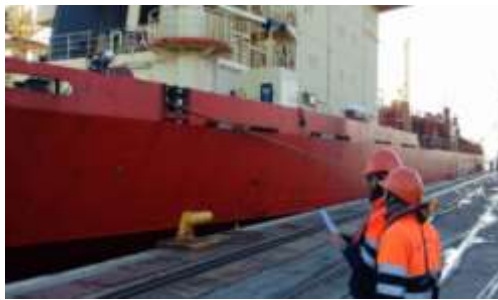
A member has noted that in recent months, there have been several accidents related to over-exertion. Most of these incidents have involved mooring operations, a job that requires physical effort due to the handling of heavy lines.

- Excess load/over-exertion (perhaps due to not knowing the weight of the load);
- Improper load handling;
- Incorrect work position (bad posture);
- Difficult posture owing to location, hard-to-reach places etc.

- Warm up!! stretch before doing work that requires considerable muscle exertion;
- Think before moving in a way that may be deemed unsafe;
- Inspect the dock area where the work is to be done. Check for obstacles or elements that may hinder the maneuver;
- Check that mooring lines are clear and are not going to get caught;
- Anticipate maneuvers by checking that both the dock and the vessel are in good condition, and notify the required parties if necessary, to avoid unforeseen events.
