IMCA Safety Flashes summarise key safety matters and incidents, allowing lessons to be more easily learnt for the benefit of all. The effectiveness of the IMCA Safety Flash system depends on Members sharing information and so avoiding repeat incidents. Please consider adding safetyreports@imca-int.com to your internal distribution list for safety alerts or manually submitting information on incidents you consider may be relevant. All information is anonymised or sanitised, as appropriate.

1 Flood light dropped to deck - corrosion

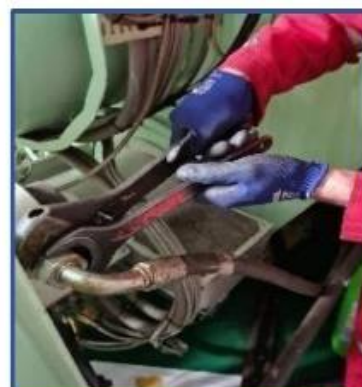
A technician was working on a hydraulic fitting with two spanners when one spanner slipped and struck him in the face. There was limited space available due to the position of the fitting. Holding one spanner in his right hand, he was loosening the fitting with a spanner in his left hand which slipped and struck his forehead causing the injuries. He was wearing safety glasses at the time but the struck safety glasses injured the bridge of his nose.

Work in the marine and offshore environment may require individuals to lift, stoop, kneel, twist, grip, stretch, reach overhead, or work in other awkward positions. In planning these activities, task risk assessments, pre-job planning and toolbox talks should consider and review the combination of ergonomic factors that could impact the task.
