1 LTI: Hand injury during diving operations

2 Learning outcomes from a real time diver recovery

4 Inhalation of toxic fumes during hot work

5 UK HSE: worker fatally injured in oil drum explosion

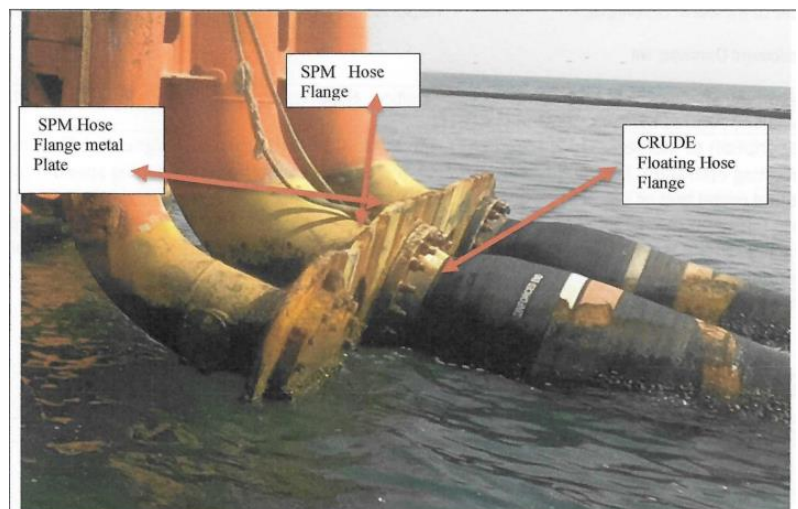
Line of Fire

A member reports a serious hand injury suffered by a diver working in the water on floating hoses at an SPM (single point mooring). Two divers were working on unbolting the flange on a floating hose on an SPM, one on either side of the hose. They were working together on the same bolts, one using a pneumatic impact wrench, the other, a flogging spanner. One of the divers started to loosen a bolt using the air tool, before the other diver was braced and ready. The flogging spanner held by the other diver jerked rapidly and trapped three fingers of his left hand between the metal plate and flogging spanner, causing a serious injury.

- Stop and think before you start – hold a toolbox meeting, make sure the task is properly risk assessed;
- Take care how tools are held, and keep yourself out of your own and others’ line of fire;
- Consider the use of extensions to tools or different tools, or different ways of doing the job, if that keeps you out of the line if fire.
