## 1 Fatality - explosive failure of corroded fire extinguisher

## 2 MSF: Tank corrosion

### 3 NTSB: Fire on laid up Dive Support Vessel

## 5 MSF: Engine damage after routine maintenance

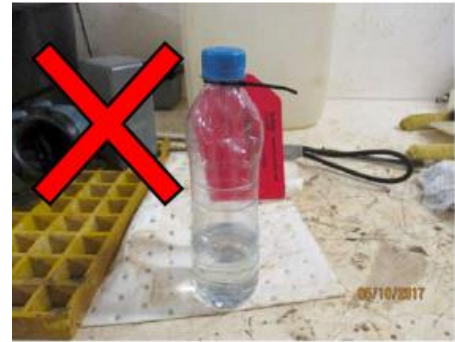
**Do not use bottles normally used for, or associated with, drinking water**

- If it is necessary to decant chemicals from their original containers:
  - Always decant the chemicals in the chemical storage area
  - Use a container in good condition, of type appropriate for the chemical
  - Ensure that containers are clearly labelled. The labels should be clean and legible and should include:
    - full product name
    - Manufacturer name
    - Material safety data sheet (MSDS) reference
