1 Overheated transformer activated fire alarm

2 Mains extension melted – not fully paid out

3 Catering crew unfamiliar with firefighting systems and emergency stops

4 Incidents relating to hatches and doors

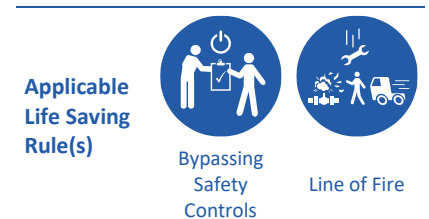
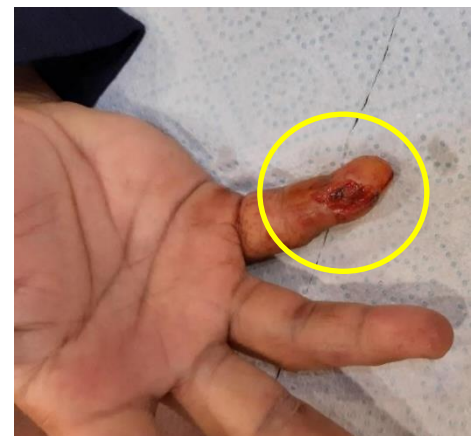
Whilst cleaning cabinets in the galley area, a crew member on a vessel sustained a bad cut to the hand from a sharp edge. This resulted in a section of skin being sliced off. The MSF notes that this was yet another **preventable injury caused during a routine job**.

- Whilst cleaning always be aware of sharp edges;
- Ensure safety checks in the galley are performed and if sharp edges are discovered they are removed, or a warning sign is put in place;
- Use most appropriate type of safety gloves for task being performed and check equipment used for cleaning;
- Hand and finger safety to be added to the risk assessments.
