1 Failure of dive chamber overhead door centre pin

2 HSE: Catastrophic failure of marine loading arm

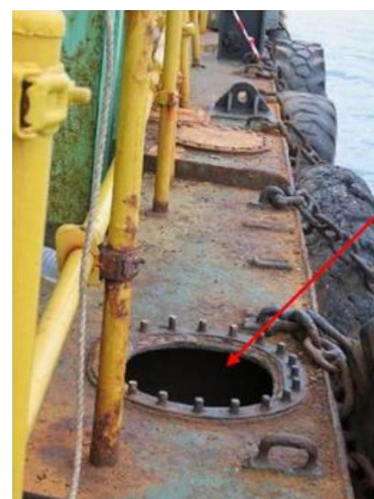
After some time, another worker entered the tank in an attempt to rescue the supervisor, but also passed out upon entry. A third worker attempted a rescue as well, but he too collapsed inside the tank.

The rest of the crew subsequently introduced forced ventilation into the tank. The second worker eventually regained consciousness and managed to climb out of the tank. The supervisor and the third worker were later extricated by the Singapore Civil Defence Force but unfortunately did not survive. This tragic accident highlights the invisible dangers of confined spaces.
