IMCA Safety Flashes summarise key safety matters and incidents, allowing lessons to be more easily learnt for the benefit of all. The effectiveness of the IMCA Safety Flash system depends on Members sharing information and so avoiding repeat incidents. Please consider adding safetyreports@imca-int.com to your internal distribution list for safety alerts or manually submitting information on incidents you consider may be relevant. All information is anonymised or sanitised, as appropriate.

2 MSF: Hand Injury Sustained During Routine Checks

3 Electrician suffered flash burn to hand

4 Failure of in-service saturation bailout bottle

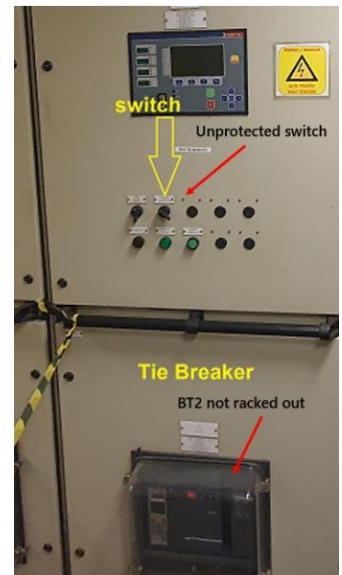
A third-party electrician on a vessel in dry dock got burnt whilst verifying the integrity of insulation on a 690 Volt bus bar. A voltaic arc was created resulting in a flash burn to his hand. Following medical treatment and a period of restricted duties, he returned to work.

- The switchboard was energized / live. The bus-tie status switch had been moved to “auto” from “off” and an [as yet] unidentified function of the Power Management System commanded bus-tie breaker 2 (BT2) to close;
- The crew ‘racked out’ most of the circuit breakers, therefore physically isolating them. BT2 was not physically ‘racked out’ because the crew mistakenly believed that this would cause the vessel to blackout. ‘Isolation’ was made using the status switch which may have been considered sufficient had the switch been effectively guarded (locked and tagged), but it wasn’t, and no further action was taken to prevent access.
