1 Serious incident: topsides started swinging during lifting

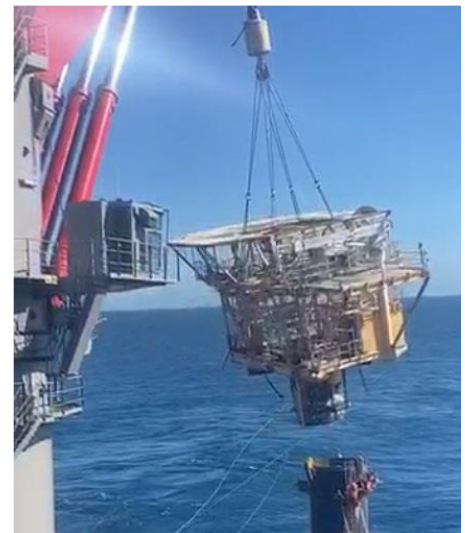
During lifting operations, a topsides connected to pre-tensioned rigging became unstable and prematurely lifted off its substructure. Two rope access technicians were on the substructure at the time of the premature lift and some personnel were on the back deck of the crane vessel when the crane trolley weak links parted.

The incident had a high potential for multiple fatalities.

- The crane vessel was on hire to an external contractor responsible for the work, including the engineering;
- The engineering assessment did not fully evaluate the effect of pre-tension and crane tip movements on the post-cut stability of the structure;
- How the crane would react to instability was not well understood.

- This incident shows how important exhaustive expert verifications are to prevent a lift from going wrong and how significant the consequences could be;
- There is a sensitivity to stability inherent in this form of monopod structure, which will need taking into account in future.
