1 NTSB: The sinking of the *El Faro* – an illustrated digest

2 Unexpected movement of conductor during diver dredging operations

3 Defective embarkation ladder quarantined – a reminder

4 USCG: Corrosion causing structural failure on accommodation ladders

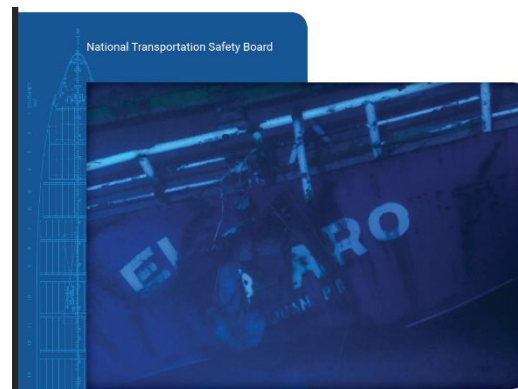
The National Transportation Safety Board of the United States (NTSB) has published an [illustrated digest](#) of its own Marine Accident Report NTSB/MAR-17/01 into the loss of the cargo vessel *El Faro*. The *El Faro* sank with the loss with all hands in a hurricane in 2015. The digest contains a description of the accident and safety issues, and summarizes some of the safety recommendations intended to prevent such an accident from happening again.

- The master's actions - from early in the voyage, the captain made decisions that put his vessel and crew at risk;
- The use of old or not up-to-date weather information;
- A late decision to muster the crew. This was left late – too late;
- Ineffective bridge resource management – the bridge crew deferred to the captain's authority and experience, rather than acting more assertively. When the crew did voice concerns, the captain chose not to listen;
- Inadequate company oversight;
- Failures in the company's safety management system;
- Flooding in cargo holds;
- Loss of propulsion;
- Downflooding through ventilation closures.

- Better and wider dissemination of information relating to weather at sea;
- Engines and other critical machinery that work at greater angles of inclination (i.e., despite more listing);
- Enclosed, not open, lifeboats, that can be launched at still greater angles of inclination;
- Protected seawater supply piping in cargo holds;

- Remote open/close indicators for watertight doors and hatches;
- Guidance that actions intended to correct a list can be dangerous if cargo is adrift;
- Class-approved damage control plans/booklets onboard all vessels, regardless of build date;
- Review of the inspection program and improved oversight for vessel inspections;
- Lifesaving appliances updated at least every 20 years;
- Personal locator beacons for crewmembers;
- Improvements to Voyage Data Recorders (VDRs);
- Improved Bridge Resource Management (non-technical skills) training – and improved meteorology training – for deck officers.
