## 1 Shackle failure during over-boarding of pennant wire and ballast chain

## 2 MSF: Dropped object during cargo discharge operations

### 3 MOB: person fell into water during gangway installation

## 5 Fuel oil hose burst during bunkering

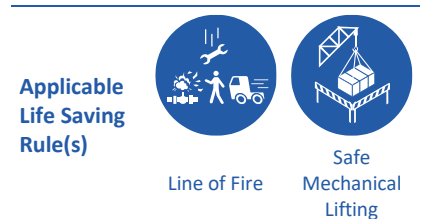
A cargo ship loaded with cargo for the renewables sector was being discharged using a mobile shore crane when a sea fastening bracket weighing about 3 kg fell out of a forklift pocket from a generator that was being offloaded and landed onto a trailer on the quayside.

The vessel was loaded with some 40 heavy lift items, each secured to a steel lifting frame with forklift pockets, each weighing about 80 tonnes, these had all been secured with 8 sea fastenings brackets per lift. The cargo was stowed over 3 decks and the sea fastenings were being burnt off by the ships' crew and swept up. During discharge of the lower tween deck a sea fastening was observed to fall from a forklift pocket. The following day another bracket was observed inside a forklift pocket.

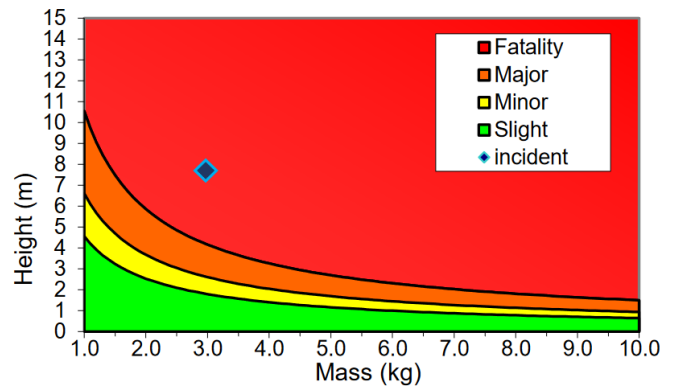
A total of 320 brackets had been burnt off. The two missed ones could have resulted in a fatality.
