1 USCG: Unexpected heavy weather dangers

2 Dropped object: dislodged flex-joint laydown tool component

3 H₂S detected in a bilge tank

4 Use of damaged electrical equipment by dock workers

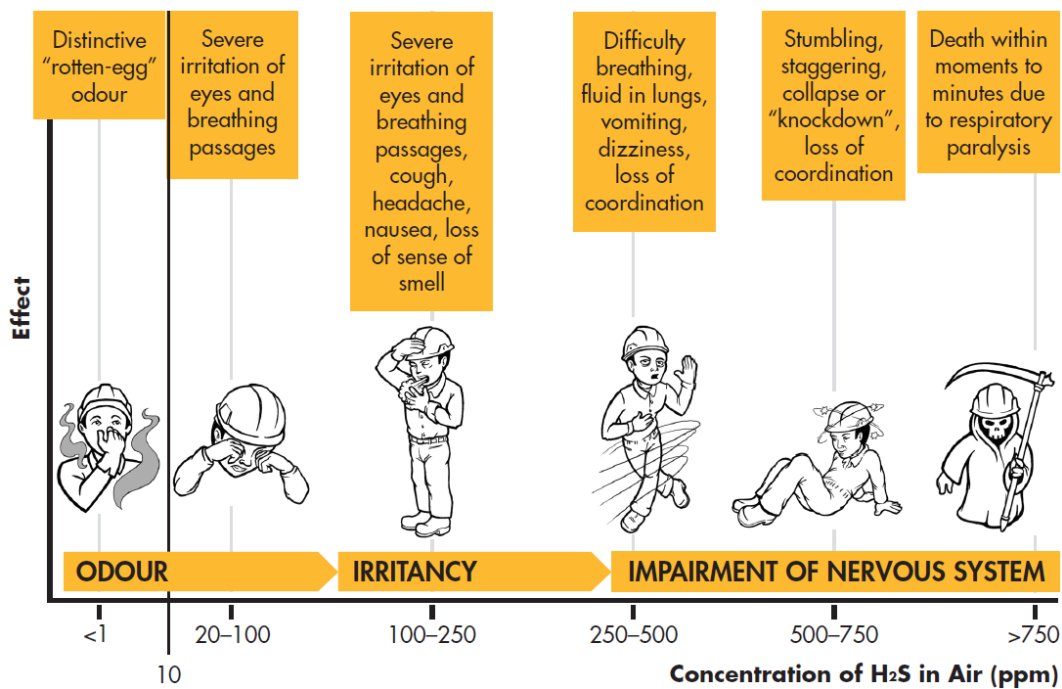
EFFECTS OF H₂S EXPOSURE

The immediate hazard was of a dangerous or even lethal atmosphere (High H₂S concentration). Seawater in (bilge) tanks, especially in the engine room, mixed with various residues and biodegradable detergents are a perfect place for the development of dangerous levels of H₂S. Failure to recognize the dangers could have resulted in explosion, intoxication or even loss of life.

- Technical
 - Bilge tank had not been dealt with or emptied for a longer period – it had not filled up;
 - Regular inspection of the tank was not easily possible;
 - Several corners of the tank had built up (stone) residue, which was not easily removed.
- Organizational
 - Lack of knowledge: during the communication with external parties it was found that some parties were uncertain how to handle the removal of the sludge from the tank without contaminating the atmosphere of the surrounding ER spaces;
 - The on-location specialist was occupied and not able to assist immediately;
 - There was not a suitable berth available for tank cleaning;
 - The required vacuum and ventilation equipment were not available and there was a delay of some days before the final removal of sludge and tank cleaning.

- Review of vessel machinery cleaning practice;
 - Clean machinery spaces with detergents when the ship is in port, preferably using fresh water
 - Check if use of bio-degradable detergents are necessary or possibility for replacement additives and cleaning agents
