COBRA Bailout System: Leakage at the Joint Between the Y-piece and the Interface Block - JFD Guidance Note

COBRA Guidance Note

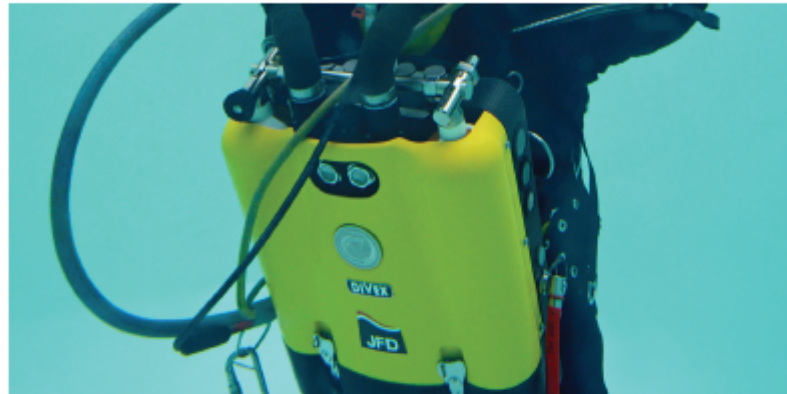
JFD have had reports that leakage has occasionally been observed at the joint between the Y-piece and the interface block.

Leakage at the joint between the Y-piece and the interface block

The joint between the Y-piece and the Interface block on the COBRA helmet uses an o-ring seal. Additionally, the joint is coated with silicone RTV as a back-up measure. Although this joint has performed satisfactorily, there have been occasional reports of gas leakage in this area, especially if the helmet receives a knock or impact. The potential for leakage is increased because the spigot and bore are not circular, therefore any twisting at the joint tends to pull the o-ring away from part of the bore causing leakage.

Any time this leakage has been observed, it has been minor and the positive pressure in the COBRA set has prevented water ingress.

A replacement o-ring has been identified, that has a larger cross section but a smaller internal diameter. This increased volume of sealing material fills the joint more fully, preventing any leak even if the Y-piece is substantially manipulated. It is not necessary or recommended to use silicone RTV in conjunction with this new seal.

Users may fit this new seal to their COBRA helmets at any convenient time.

Replacement o-ring part number RN0813-7. These will be made available to users on request.
