IMCA Safety Flashes summarise key safety matters and incidents, allowing lessons to be more easily learnt for the benefit of all. The effectiveness of the IMCA Safety Flash system depends on Members sharing information and so avoiding repeat incidents. Please consider adding safetyreports@imca-int.com to your internal distribution list for safety alerts or manually submitting information on incidents you consider may be relevant. All information is anonymised or sanitised, as appropriate.

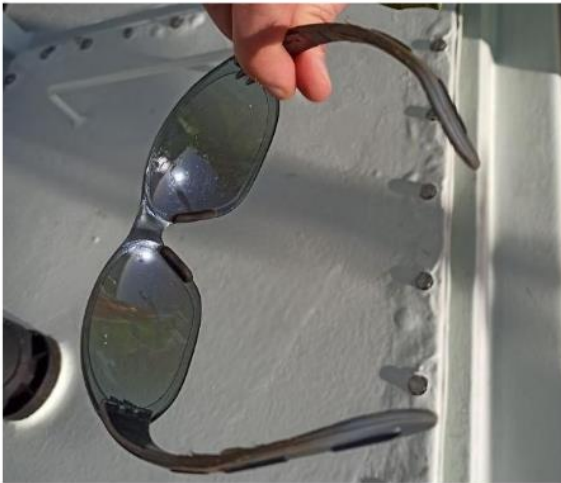
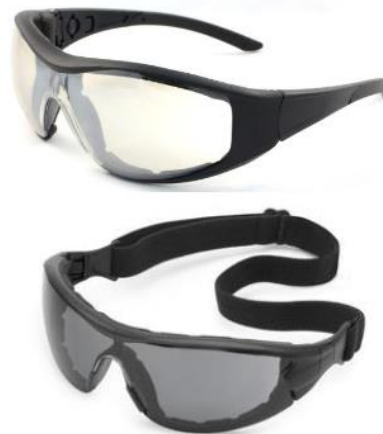
- The seafarer was wearing safety glasses that were relevant to the routine maintenance task, however the change of task to chipping would have required a change of safety eyewear to goggles.
- Though the circumstances of the job changed, the job was not stopped nor appropriate risk assessment reviewed;
- There was insufficient planning for the job and the risk assessment in use was generic without adequately addressing all hazards and controls.

Left picture shows Safety Glasses in use, right shows 2 x examples of Spoggles

- All onboard Risk Assessments were reviewed to ensure that the correct eyewear is mentioned as per the company PPE requirements;
- There was a renewed focus on eye safety;
- Following review and discussion with the crew, better safety glasses – “Spoggles” – were sourced, which meet the requirement of safety glasses and safety goggles.
