1 Mooring near miss: Guide roller pin suffered material failure

3 NTSB: Dangerous engine failure – improper torquing

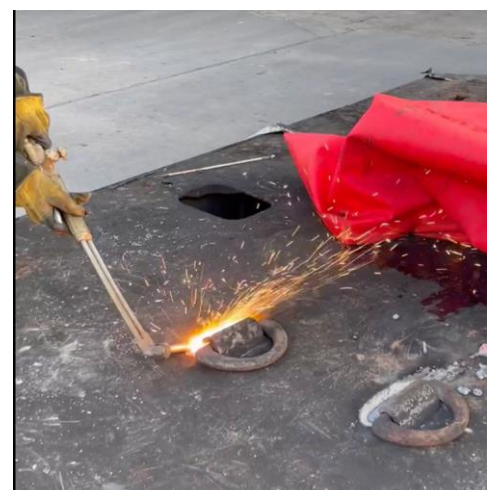
Investigation determined that sparks and molten slag from the hot work had fallen through the gaps between the tween deck pontoons. The molten slag had also burned through the fire blanket and had fallen through the gap at several locations. The sparks and molten slag had landed on and ignited the plastic covering and protecting the cargo. Some of the cargo was damaged from the fire and other cargo was damaged by the smoke.

- Hot work permits should be very specific to the exact risks associated with the specific hot work, specific location, specific time, and specific hazards;
- Fire watches are critically important during hot work to prevent fires. To be effective, the fire watch must be vigilant to the potential of fire in all the adjacent areas;
- Screens, shielding and fire blankets should be effectively placed to contain sparks and molten slag produced by hot work;
- Hot work permits should specifically address risks to all nearby cargo or any other flammable materials that may be exposed including the need for additional protective covers.

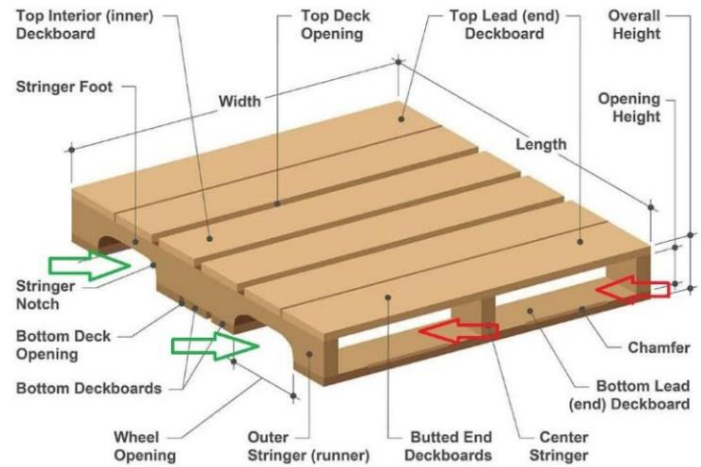
Incident #1: Lifting strops were passed through the side of the pallet (See red arrows in diagram) allowing the tension to be placed on the deck boards. The load weighing approximately 150kg was centred on the pallet. The stress on the deck boards allowed them to separate from the pallet eventually failing and allowing the load to fall to the deck.

Incident #2: Loose items were placed on a pallet which was to be loaded onboard. During the lift, the pallet came in contact with slings attached to a gangway stowed in the immediate area. The contact caused the pallet to shift allowing a box of copy paper to fall off and fall to deck. Fortunately, there was no-one in the immediate vicinity when the box landed.

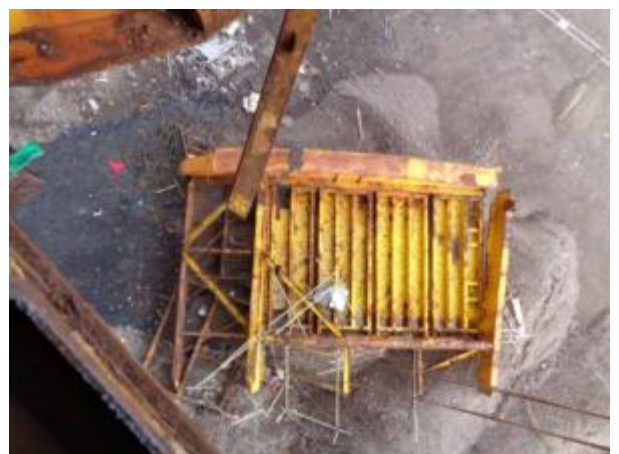
It was **not recognised by the planning team** that one of the platforms did not form part of the main structure and was attached to the platform using bolts that had corroded over time. This affected the structural integrity of the platform and the methodology required to remove it safely. During the cutting of bracing beams, the platform unexpectedly collapsed causing one of the employees to fall 15 metres.

An investigation by the Health and Safety Executive (HSE) into the incident found that the company had failed to carry out a full structural appraisal of the platform prior to demolition. This would have informed the risk assessment and method statement being used by the cutting crew at the time of the incident to ensure that the work could have been carried out safely.
