## COBRA Advisory Notice: Setting Positive Pressure

### COBRA Guidance Note

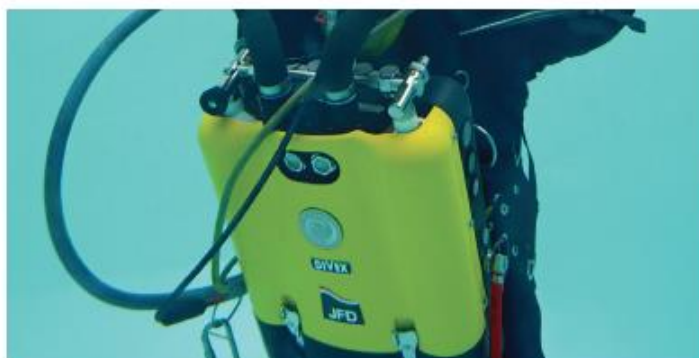
Some users have been reporting bulging of the COBRA demand valve diaphragm alongside difficulty setting the positive pressure.

1. Bulging or Distortion of diaphragm
2. Difficulty in setting positive pressure
3. Seemingly achieving a stable positive pressure, which then suddenly increases, sometimes with an audible popping noise

1. Firstly, it is necessary to determine whether the diaphragm is actually bulging or merely sitting asymmetrically. Bulging is defined as having any protrusion beyond the shape developed by the diaphragm when the set is in standby mode and gas is venting from the external relief valves (due to lightly purging the demand valve). If any bulging is evident, the diaphragm must be replaced.

3. Although JFD has observed this effect, we have not managed to recreate it at JFD sufficiently often to perform a full investigation. This effect could be related to overtightening (or previous overtightening) of the diaphragm retaining ring. JFD recommends replacing the diaphragm if this effect is observed.

In all cases JFD now recommend a torque of 8-10 in-lbs for the diaphragm retaining ring.
