IMCA Safety Flashes summarise key safety matters and incidents, allowing lessons to be more easily learnt for the benefit of all. The effectiveness of the IMCA Safety Flash system depends on members sharing information and so avoiding repeat incidents. Please consider adding safetyreports@imca-int.com to your internal distribution list for safety alerts or manually submitting information on incidents you consider may be relevant. All information is anonymised or sanitised, as appropriate.

1 Third-party truck not in appropriate or safe condition

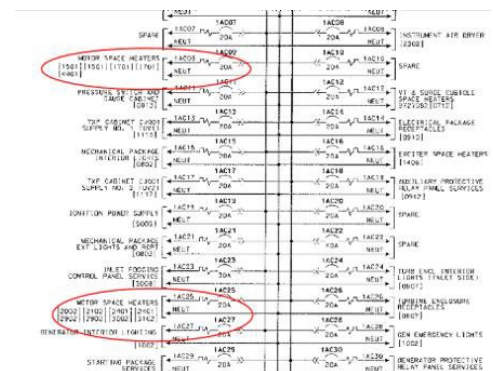
Energy
Isolation

3 Equipment found live: drawings incorrect for Lock-out/Tag-out

- An increased focus on LOTO during this outage allowed electrical personnel to find the error;
- The electrical working foreman noticed the hazard and it was corrected;
- No-one was harmed.

- The drawings were incorrect, but as this work was infrequent, it had not been noted previously;

- There was a review of work practices with plant staff to communicate the issue as a result of this alert;
- Ensure all appropriate or possibly relevant electrical equipment is locked out/tagged out;
- **Always “check for dead”.**
