1 Near miss: divers umbilical drawn beneath a load

2 Incorrect as-built drawing configuration

3 Engine room fire on a ferry

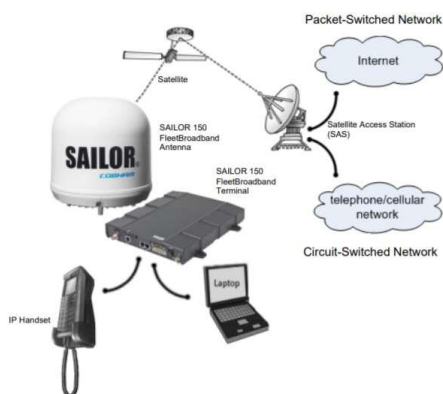
Sailor 150 Fleet Broadband system

The shore service team used radio frequency (RF) detection and spectrum analysis equipment to detect and analyse RF signals transmitted by various sources, after which it was identified that the interference issue was caused by a factory-fitted SAILOR 150 Fleet Broadband which was not in use, but not disconnected.

The radio frequency interference came from a failed connector panel of SAILOR 150 Fleet Broadband System. This caused an outage of GNSS positioning systems for the surrounding vessels in close vicinity.

- Failed equipment can transmit a radio signal which can interfere with the communication or navigational equipment nearby;
- Check for any similar equipment onboard that is not in use, but not disconnected or powered down – removal may be worth consideration.
