COBRA Bailout System: Top Handle Failure

COBRA Guidance Note

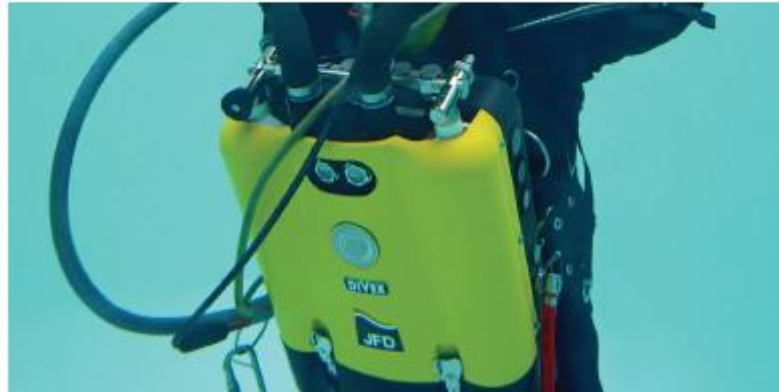
The top handle on a COBRA set failed while the COBRA set was being lifted or lowered on a pulley system.

The stitching was found to have failed at one eyebolt. The COBRA set dropped but the other eyebolt and the D-ring remained connected to the COBRA set.

Users are reminded to check the condition of the handle and stitching before any lifting operation and to clip the lifting tackle into the D-ring as intended.

As a result of user feedback, JFD will shortly be reviewing the handle arrangement and will communicate any changes / improvements via a further guidance note.
