1 Umbilical management – near miss

2 Lost ROV incident

3 Incorrect gangway rigging

4 Blocked emergency exit hatch

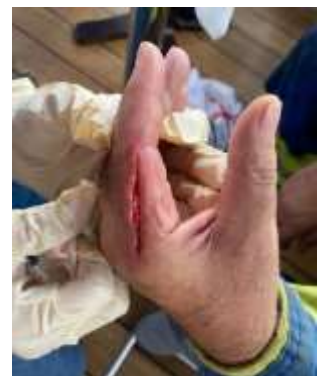
He missed the sheath with the knife and pushed the knife into and down his left Index finger, causing a large deep incision, requiring surgery to correct possible tendon damage, and close the wound.

Our hands are our most used tool. Protecting your fingers and hands is important. Damage to the nerves in your fingers and hands, loss of a finger, skin burns or allergic reaction, can negatively impact the quality of your work, your productivity – or worse – end your career and seriously detract from your quality of life.

- Only use knives for their intended purpose;
- Never use “homemade” tools;
- Cut away from yourself, away from your body, keeping all fingers out of your cutting line;
- Use all personal protective equipment required including gloves;
- Cut on a stable surface;
- Stay focused;
- Don't rush, take plenty of time, care and pay attention to what you and your knife are doing.
