1 BSEE: Person injured when safety mechanisms failed

2 Dropped spanner falls 15m

3 Equipment Damage: Dropped Object from tiltable lay system

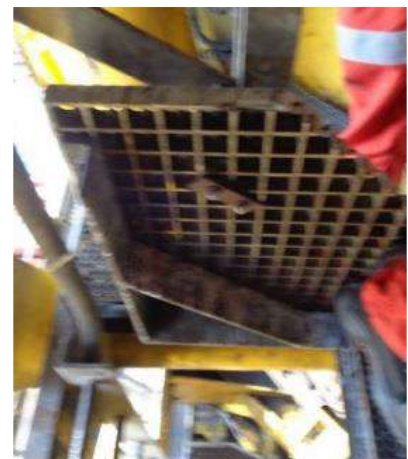
- Before this event, the inspection manhole gate had been damaged in a previous unreported incident. Subsequently some minor repair work had been undertaken which involved the removal of the grating from the gate/bracket. The hinged bracket was seized in the upright position and at the time it was not considered a dropped object hazard due to it being firmly secured to the TLS structure.
 - The seized bracket was not fully repaired following the original incident;
 - The latent hazard posed by seized bracket was not identified as a potential DROPS or as a clashing hazard.

(Right) Intact manhole door raised, showing bracket in upright position. The dropped object bracket was in similar position due to previous unreported incident.

- Although the first incident was recorded within the pipelay team handover notes, there was a failure to formally report it within the company incident reporting system - all damage incidents should be reported to ensure the correct level of investigation, and so that corrective and preventative actions are identified and implemented;
- The equipment design and layout failed to identify the clash points created when manhole gates were left in the open position.
