## **COBRA Breathing Hose Connection Issues – JFD Guidance Note**

## COBRA Guidance Note

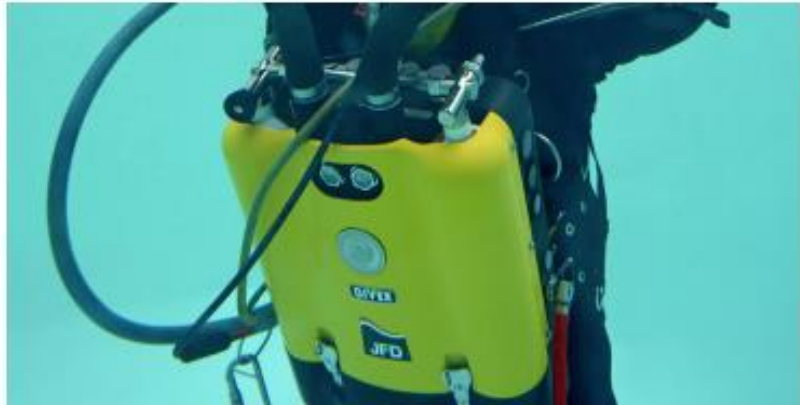
Two users have recently reported incidents where they have found a COBRA breathing hose no longer connected to the backpack. Some time ago, 2 users also reported a breathing hose becoming detached at the helmet connector.

When the breathing hose is not properly connected, the COBRA set will flood and no longer be capable of supplying safe bail-out gas to the diver. Even if the issue is subsequently rectified, the backpack will remain flooded. Even if the backpack is only partially flooded, there is a risk that caustic liquid (water+sodalime) will be delivered to the diver when inhaling.

In all the reported cases, JFD believes that the hose nut was not fully engaged with the thread on the backpack / helmet connector. Due to the stowage / working arrangements in some bells, JFD understands that it is necessary to fit the breathing hoses to the backpack with the connectors facing away from the user. If this is the case, it is essential that the connection is properly inspected afterwards to ensure proper engagement.

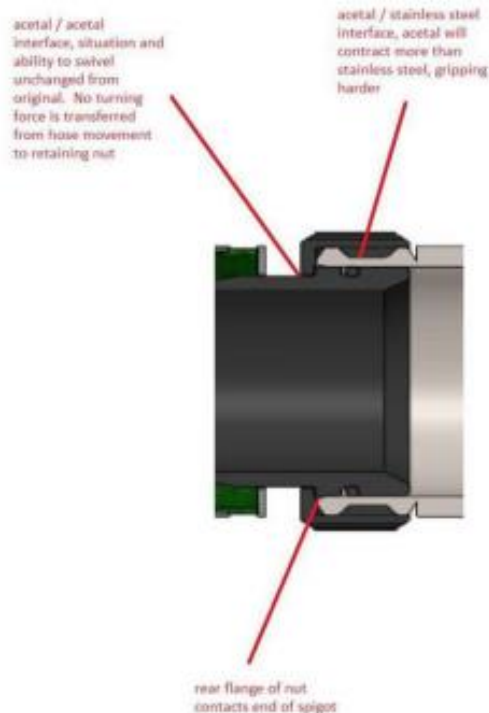
Users have speculated if the recent material change (from acetal to stainless steel) to the connector has increased the likelihood of the nut backing off during a dive. JFD does not believe that this is the case for the following reason:-

The thermal expansion coefficient for stainless steel is 16 micron/metre/deg C, for acetal 110 micron/metre/deg C. The stainless steel item will contract less than the plastic item (for the same temperature drop), therefore the contracting acetal nut will grip the stainless steel connector more than the acetal connector (assuming a temperature drop from the bell to the water). It is important to note that the acetal nut is still fitted to an acetal hose end i.e. the nut is no more likely than before to grip on to the hose end and be turned by movement of the hose.
