The UK Marine Accident Investigation Branch has published [Safety Digest 1/2023](#), consisting of lessons from recent Marine Accident Reports. IMCA has reviewed the digest and here passes on for members interest, some but not all of the incidents in it.

1 MAIB: High pressure oil leak causes a fire in the engine room

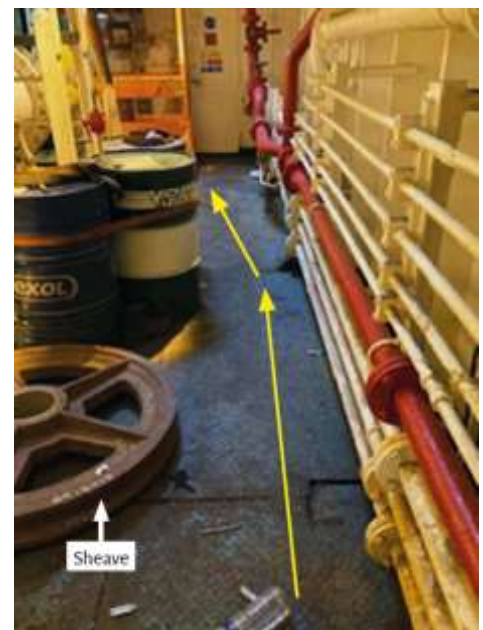
Line of Fire

- Fatality: person crushed when secured material fell on him
- Update to SF 08/21: fatality – person crushed when secured material fell on him
