1 Lifting chains parted – hydrogen embrittlement

2 Davit hook failures

3 Sheave became detached during lifting operations

4 Near Miss: personnel transfer basket hit structure

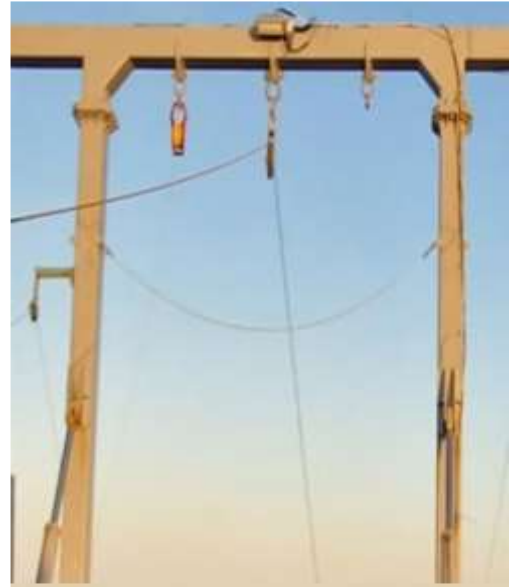
During recovery operations of marine geophysical sensors, a sheave parted from a swivel connection on the A-frame. The sheave fell approximately 6m to the deck below. No personnel were underneath the sheave, however had the sheave struck an individual, it could have caused serious injury.

- When the sheave was installed, the secondary retention (securing sling) was considered unnecessary and removed - there was no independent verification / quality check (QC) carried out;
- Prior to the incident, there had been numerous opportunities including one by an independent (third party) inspector to identify that the sheave was incorrectly installed;
- There was inadequate development and control of the lifting equipment records / register.

- **Equipment** - Design changes were made after the incident to remove the swivel connection and replace it with a pad eye thereby reducing the potential for incorrect connection;
 - Secondary securing slings were fitted to all sheaves. Additionally, a cable was installed between the A-frame legs to act as another barrier should primary and secondary retention fail. The sensor tow wire straddles this cable, so if the sheave falls it slides down the tow cable rather than drop (see image to the right).
 - Monitoring, tracking, inspecting, and provision of guidance for lifting equipment, accessories and rigging was improved.
- **Procedures** - Written installation and maintenance instructions should be provided with all equipment/sheaves.
