IMCA Safety Flashes summarise key safety matters and incidents, allowing lessons to be more easily learnt for the benefit of all. The effectiveness of the IMCA Safety Flash system depends on members sharing information and so avoiding repeat incidents. Please consider adding safetyreports@imca-int.com to your internal distribution list for safety alerts or manually submitting information on incidents you consider may be relevant. All information is anonymised or sanitised, as appropriate.

1 Restricted air supply to diver

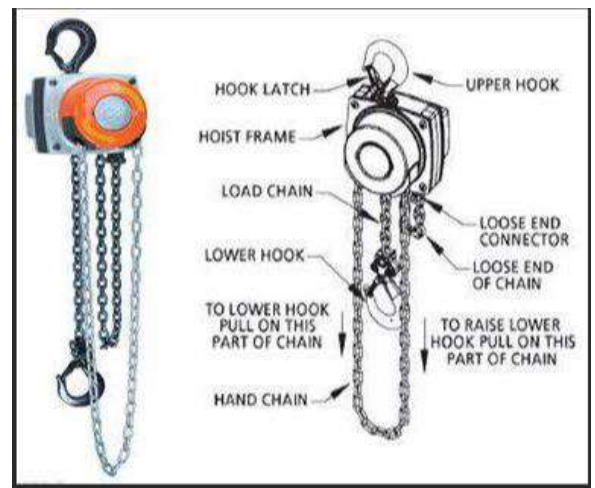
- Near-miss: Safe use of chains in rigging

- A Safety stand-down was held to discuss this incident with all involved and lessons from it were to be included in future training material for apprentices and new hires;
- Have an increased awareness of ensuring chains are free when moving loads;
- Keep the "bigger picture" in mind – don't get so focussed on the detail that something obviously potentially unsafe escapes your attention.
