## 1 Compressed air rather than oxygen supplied to divers

## 2 Failure of proportional valve in saturation chamber control

**3 Case study: saturation diver fatality due to hydrogen sulphide**

## 4 Case study: confined space fatalities due to Hydrogen Sulphide

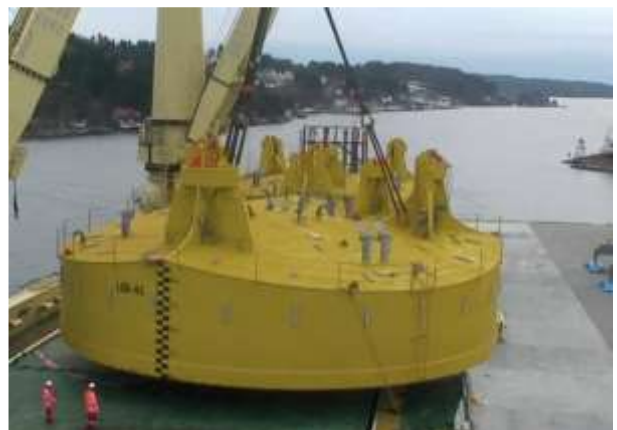
Shortly after starting the operation, the dive supervisor saw the attendant at the bottom of the ladder collapse. On seeing this, the supervisor impulsively climbed down the ladder to assist, *without wearing a B.A. set*. Before he could reach the attendant, he too collapsed. The alarm was raised and the ventilation rate was increased to drive out the “sour gas” from inside the spud can. As soon as this was done, a large quantity of gas emerged out of the narrow opening of the spud can and the “stand by” person was affected and collapsed.

All three persons who entered the spud can died; the “stand by” person“ was resuscitated, evacuated and admitted to intensive care at hospital.

*Jack-up rig leg “spud can” removed for maintenance (Image for illustrative purposes only)*

- Cause of death as determined by the Coroner as asphyxia. Circumstantial evidence pointed to inhalation of H<sub>2</sub>S anticipated in the spud can. Spud can is almost 5 m in height and because of its typical internal construction, has numerous poorly ventilated nooks and corners;

- The supervisor entered the spud can without B.A and collapsed immediately;
- The “Stand by” person, not wearing B.A, was affected by the gush of gas coming out of the opening due to forced ventilation but being in the open, quantity of gas inhaled was much less and this person survived.

- Proper planning and appropriate training for enclosed/confined space entry, particularly for third-party contractors;
- Such training should include:
  - Active monitoring for H<sub>2</sub>S gas, including both personal and area monitoring;
  - Understanding of the dangers of H<sub>2</sub>S and how it behaves;
  - Where to wear personal detection monitors, preferably over the chest pocket or on the collar, i.e. as close as possible to the nose;
  - Proper use of correct breathing apparatus;
  - Use of the “buddy” system;
  - Training and drilling of emergency response team;
  - Proper use of Permit to Work system and safe systems of work;
