## 1 Line of fire near miss during lifting operations

**2 Failure of personal isolation procedures: crane damaged when it was used inappropriately**

## 3 Two hand injuries

## 4 LTI - Finger crush whilst operating safety gate

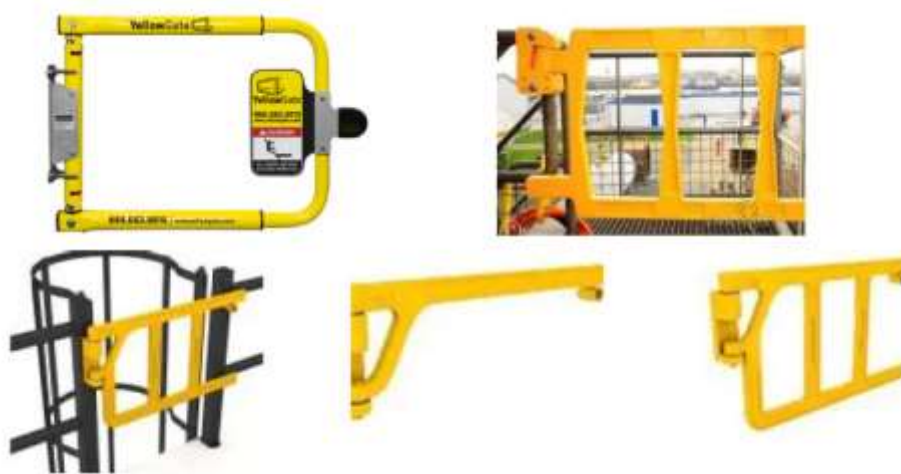
Our member notes different or alternate safety gates for consideration:

- <https://www.yellowgate.com/product/swing-gates/>
- <https://www.materialshandling.com.au/products/flex-impact-single-and-double-axes-gates/>
- <http://cablesafe.com/dropped-objects-prevention/self-closing-safety-gates/>
