1 Diver in the bell hit by falling object

2 Divers lifted off seabed by Clump Weight

3 Leak in hot water system for saturation divers

4 Chain hoist paid out unsupervised near running main engine

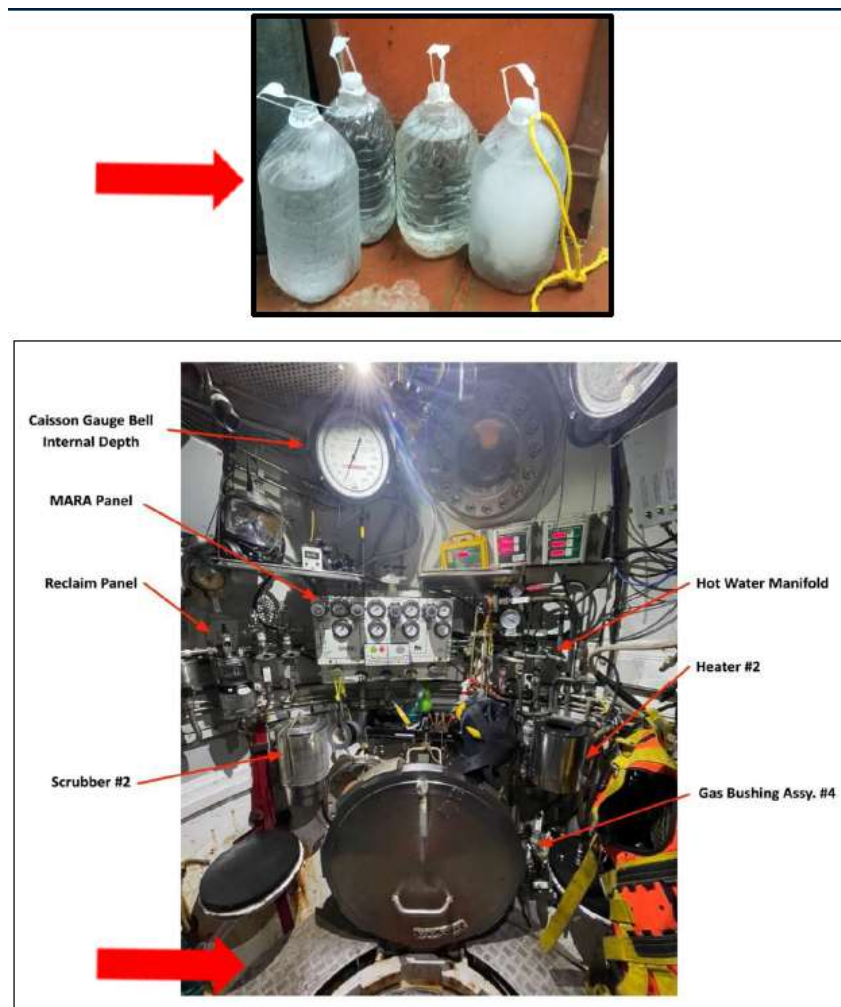
A diver in the diving bell was hit and slightly injured by a water bottle containing a gallon of water (4.5kg). Diver #1 left the bell and was handing over to the next bellman. In the bell the remaining divers were organizing their gear before departing the bell. They were moving a partially frozen one gallon water bottles when a handle on a water bottle broke and the bottle fell into the transfer lock striking the diver #1 on left side of his head and then onto his shoulder.

The handle of the frozen water bottle broke and fell on the diver standing at the bottom of the transfer lock.

The bell temperature was elevated due to shallow water diving and the bell being well insulated. Divers were bringing in frozen bottles of water to help lower the internal temperature.

- Deviation from procedure, no matter how minimal has the potential to trigger an event leading to accident;
- No risk assessment was completed for this change in operation;
- A “Hazard Hunt” was initiated - **focusing on routine tasks**;
- Arrangements were started for installing a diving bell chiller to regulate higher temperatures;
- Updated a Management of Change process and risk assessment for continued use of frozen bottles as a short-term solution, focusing specifically on proper securement and material handling to prevent dropped objects.
