IMCA Safety Flashes summarise key safety matters and incidents, allowing lessons to be more easily learnt for the benefit of all. The effectiveness of the IMCA Safety Flash system depends on members sharing information and so avoiding repeat incidents. Please consider adding safetyreports@imca-int.com to your internal distribution list for safety alerts or manually submitting information on incidents you consider may be relevant. All information is anonymised or sanitised, as appropriate.

1 Unauthorised entry into confined space

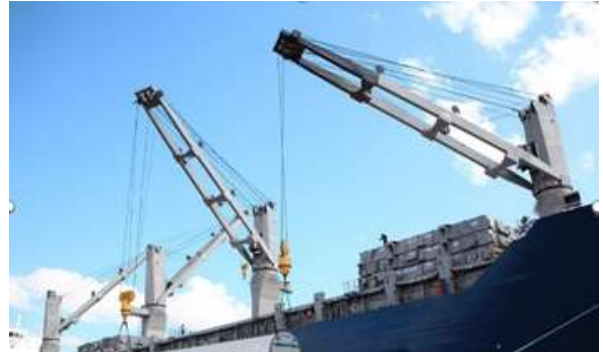
The USCG noted that *investigation revealed that corrosion, wear, and monotonic ductile overload of the wire rope caused the failure*. Further, it was concluded the wire rope was still within its permitted service life but should have been replaced prior to the incident due to the corrosion and wear.

Figure 1: Cargo ship offloading cargo utilizing shipboard cranes. Photograph courtesy of Macgregor.com.

The US Coast Guard strongly recommends that vessels equipped with shipboard cranes:

- Implement increased load testing frequency to verify wire rope integrity between class society mandated 5-year load tests;
- Are provided with and utilize pressure lubricating devices as recommended by the manufacturer for routine maintenance;

- Ensure maintenance tracking systems align with manufacturer's recommended maintenance protocol, including the period of employment and renewal of wire ropes;

- Consider shortened periods of employment and early renewal of crane wire ropes to prevent corrosion and fatigue induced failures;
- Instruct and train all personnel to never position themselves under cargo suspended by any crane, even temporarily;

- Ensure all shipboard crane operators are properly trained and cognizant of industry best practices;
- Implement increased wire rope visual inspection frequency;

- Degrease and remove all lubricant prior to crane wire rope visual inspections to ensure surface defects are not concealed.
