IMCA Safety Flashes summarise key safety matters and incidents, allowing lessons to be more easily learnt for the benefit of all. The effectiveness of the IMCA Safety Flash system depends on members sharing information and so avoiding repeat incidents. Please consider adding [safetyreports@imca-int.com](mailto:safetyreports@imca-int.com) to your internal distribution list for safety alerts or manually submitting information on incidents you consider may be relevant. All information is anonymised or sanitised, as appropriate.

## 1 Person struck and injured during lifting operations

**2 Person pulled to deck by fall arrest harness**

**3 High potential: sea water inlet pipe leakage in engine room**

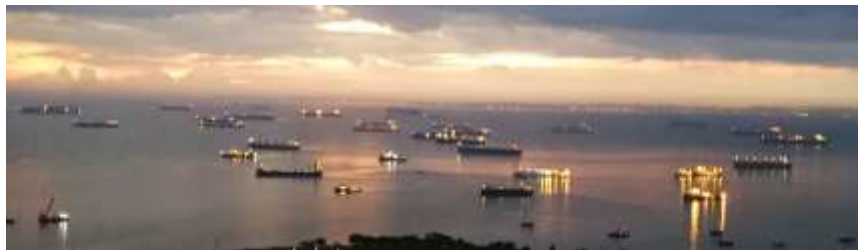
An intruder armed with a knife boarded a vessel at anchor in Luanda, Angola. The intruder was discovered during the hours of darkness when a member of the crew was conducting a security patrol. An unidentified individual was observed on the starboard side of B-deck. The crew member immediately reported the sighting to the bridge and the alarm was raised, alerting others to the presence of the intruder who was armed with a knife. The general alarm was activated, and the Master was called to the bridge.

Upon hearing the alarm, the unidentified individual jumped overboard escaped aboard a skiff. Before fleeing, the individual removed one life buoy with a lamp and two life buoys, and threw them into the water.
