IMCA Safety Flashes summarise key safety matters and incidents, allowing lessons to be more easily learnt for the benefit of all. The effectiveness of the IMCA Safety Flash system depends on members sharing information and so avoiding repeat incidents. Please consider adding safetyreports@imca-int.com to your internal distribution list for safety alerts or manually submitting information on incidents you consider may be relevant. All information is anonymised or sanitised, as appropriate.

1 Loss of heading control on an FPU during diving operations

2 Implosion of chemical tank

4 Person injured when chain hoist container failed at securing point

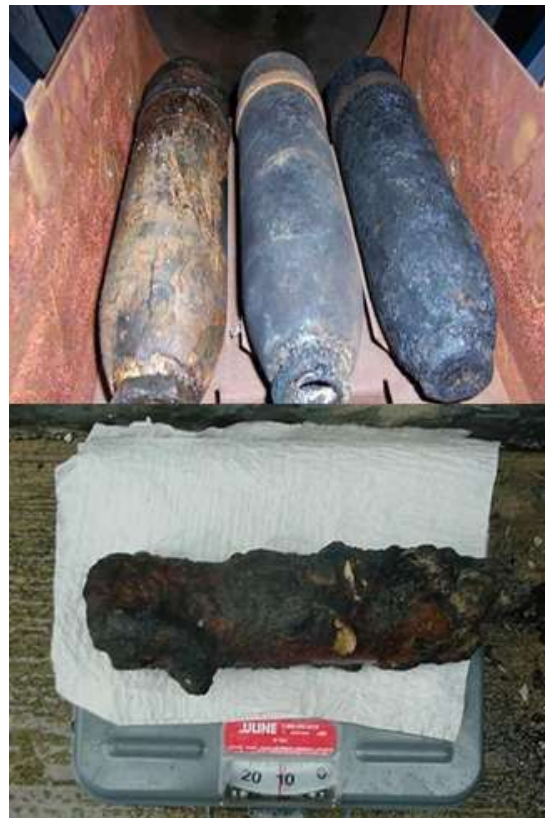
A deckhand on a clamming vessel was severely burned when a canister was dredged up and brought onboard with clams and other debris. The canister likely contained mustard gas or another blistering agent, but did not display any obvious visual, audible, or odour indicators of discharging content. A member of the crew discovered the canister and threw it back overboard. Several hours later he developed a severe rash that required professional medical treatment. Mustard gas is a chemical weapon developed during World War I. Millions of pounds of this product, other chemical weapons, bombs, torpedoes, artillery shells, and munitions were routinely disposed of and remain in U.S. coastal waters.

- Review their navigational charts to ensure the areas in which they are working are not near labelled “Explosives Dumping Areas.” Such areas should be given a wide berth and seafarers should recognize that seabed topography can change and that objects can move significant distances from their original disposal areas;
- Carefully record the position of any munitions encountered and returned to the sea;
- Immediately report discovery of unexploded munitions to the appropriate local authorities.
