1 Dropped lifting beam due to parted soft stop

2 Vessel collided with platform

3 Diver's umbilical trapped during a pipeline flooding operation

4 Stored energy - dislodged pin causes injury

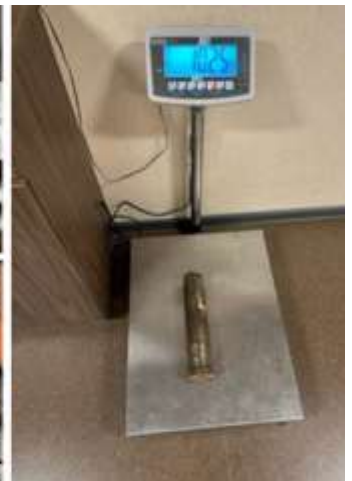
Size and weight of pin

- The task risk assessment (TRA) for this task did not consider the use of a hydraulic jack for removal of the pin, nor did the toolbox talk (TBT) before starting work;
- A change was then made during the task (introduction of the jack), but the new risks were not thought through at all. Nobody in the work team thought to intervene and stop the job due to the change in method and equipment;
- During the operation of the jack, one person decided to switch positions to get a better view and to try and release the pin. That person got directly into the line of fire. There was significant stored energy now pushing behind the pin and that risk was not recognised.

- Our member noted that lessons were not being learned from previous incidents involving getting in the line of fire. A fresh review on the line of fire risks was initiated, considering all the potential energy forms, including release of stored energy;
- If something changes during a task - **stop the job, and reassess;**
