1 Loss of pressure to diver's primary air supply

2 Equipment fell on someone's leg causing injury

3 Electric shock after water ingress to switch

4 Emergency musters and drills

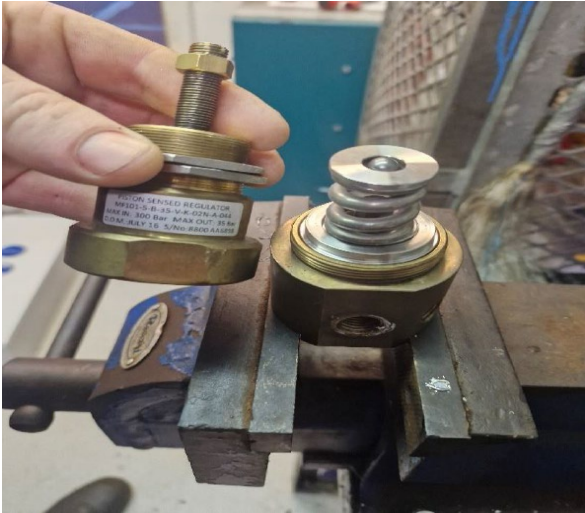
Regulator Body Removed

A diver working underwater experienced a pressure drop from the primary HP supply regulator. The diver was recovered safely, and tests were subsequently carried out on the surface, and the same pressure loss was observed. The regulator was removed from the panel, stripped, and inspected. During the removal of the sensing assembly, old/dry lubricant was observed on the bottom end. The sensing assembly was checked by moving the shaft up and down simulating what would occur within the regulator during use. Friction between the shaft and the sealing face was evident, as it would not move as freely during the up and down movements through the sealing face due to the dry lubricant.

The test identified that this sticking would occur when there is light breathing from the diver as there would not be sufficient pressure on the sensing assembly to cause it to move freely up and down regulating the pressure. In contrast, with heavy breathing, there is ample instant pressure on the assembly which would then allow it to regulate the pressure better.

- Action taken:
 - Increased planned maintenance schedule frequency for checks, test and cleaning of seal kits, sensors and panel regulators to every 6 months;
 - Tested and cleaned all other regulators on the panel and gas racks flow tested and cleaned, and changed planned maintenance schedule to every 6 months;
 - Keep careful records of lubricant identification and batch number;
 - Ordered newly updated sensors and more seal kits with new and more sensitive sensors;
 - Liaise regularly with manufacturer for any information on new types or upgrades that may be available.
