IMCA Safety Flashes summarise key safety matters and incidents, allowing lessons to be more easily learnt for the benefit of all. The effectiveness of the IMCA Safety Flash system depends on members sharing information and so avoiding repeat incidents. Please consider adding safetyreports@imca-int.com to your internal distribution list for safety alerts or manually submitting information on incidents you consider may be relevant. All information is anonymised or sanitised, as appropriate.

1 Side scuttle (porthole) knocked out by wave impact

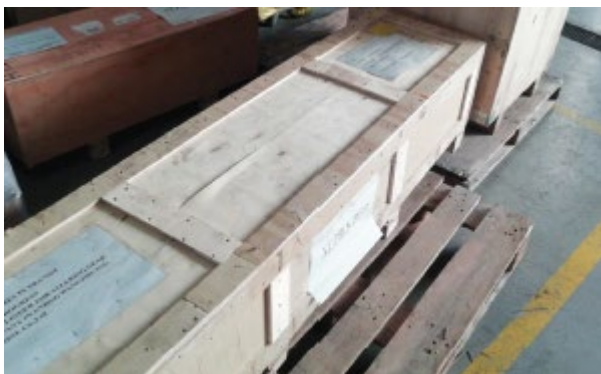
Condition of the cargo box before and after the incident

Pump and hydraulic ram dropped

- The cargo was not prepared properly: the wooden box in which the hydraulic ram was stored did not contain any support or cargo securing structure; the hydraulic ram was loose and could slide around the box due to inertia and the lack of support;
- The two boxes were placed onto the pallet but were not secured by any means as strapping or shrink-wrapped to the pallet. This allowed the boxes to move more freely around the pallet surface and change the balance and centre of gravity of the load;
- The pallet was loaded with two wooden boxes, one with the ram that weighted 365 kgs and the other box contained a pump weighed 93 kgs, so the pallet was unbalanced;
- There were several gusts of wind during the operation that could have swayed the load during lifting.

- Only trained and certified vessel crew should be involved in lifting operations;
- Cargo delivered to the vessel should be visually inspected by competent personnel to assess their condition before lifting. Any doubts as to their integrity should be reported to the vessel master and client as required, and the cargo rejected until safety is confirmed;
- Wooden pallets are not designed to be lifted. Pallets do not have a safe working load and slings can cause the pallet to fail regardless of the type;
- Cargo should be properly secured and that securing should be assessed by competent personnel before the lift starts;
- Check the weather, particularly the wind, before and during lifting operations.
